Task 13 Performance, Operation and Reliability of Photovoltaic Systems

Quantification of Technical Risks in PV Power Systems

2021

Report IEA-PVPS T13-23:2021
February 2022

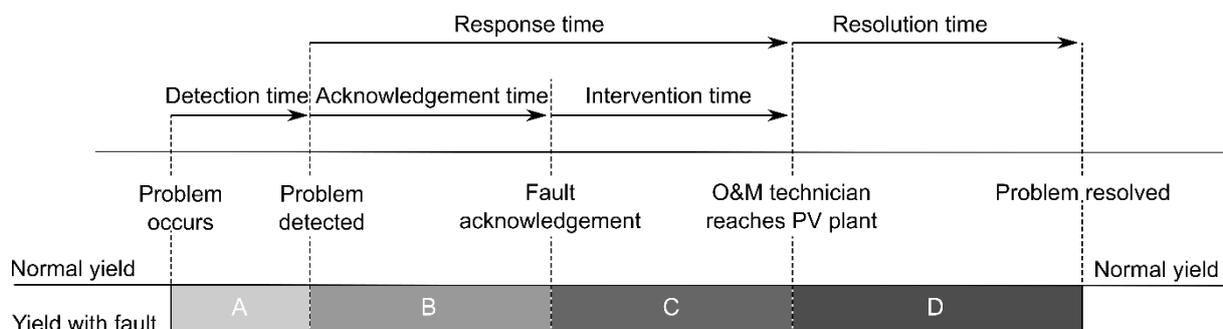
Figure 1: Parameters to calculate the O&M contractor KPIs, extracted from the monitoring and ticketing system [19].

While there are specific parameters for each quantification method, this chapter presents the recurring indicators typically used in contracts in the PV sector (s. Figure 1). Further definitions can be found in the Task 13 report [12] or [20].

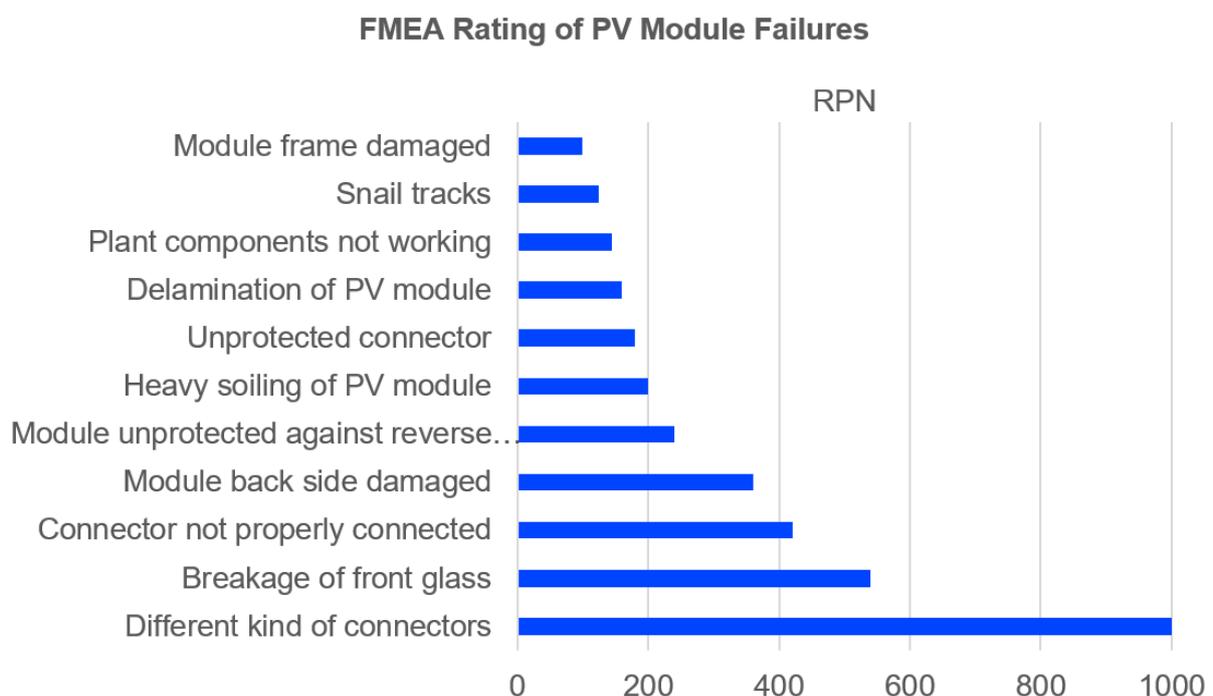
Figure 2: Example of rating of PV module failures based on classic FMEA. The rating of the technical risks was based on the statistics of failure reports from TÜV Rheinland. RPN is the product of S, O and D where each factor is an integer between 0 and 10 [2].

With the resulting Risk Priority Number (RPN) the evaluated risk can be ranked and compared with other risks. Figure 2 gives an example of FMEA rating of PV module failures. The disadvantage of this approach is that further usage, i.e. within a financial model, is limited [2].

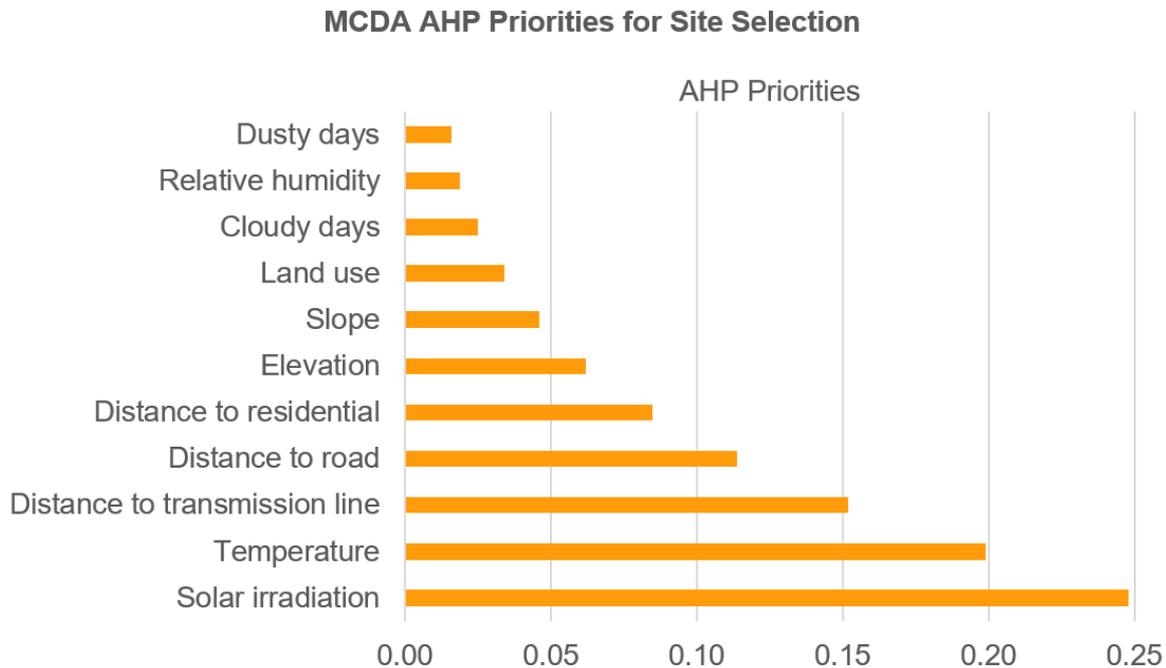
Figure 3: Example of AHP priorities to determine the optimal PV plant location in southern Iran. The sum of all priorities is equal to 1. Adapted from [24].

One MCDA known for robustness is the Analytic Hierarchy Process (AHP) method developed by Saaty [23]. It is based on three principles: building hierarchies, priority and logical consistency. Priorities are absolute numbers between 0 and 1 and always add up to 1. Figure 3

shows the calculated priorities to determine the optimal location for a large PV plant in southern Iran [24].

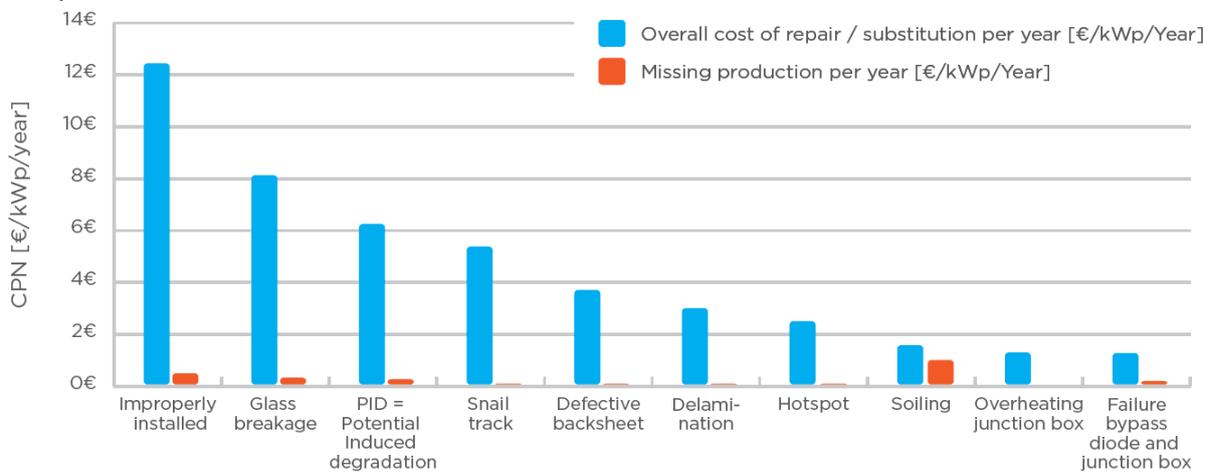
Figure 4: CPN, repair costs and performance losses for top 10 risks for PV modules [30].

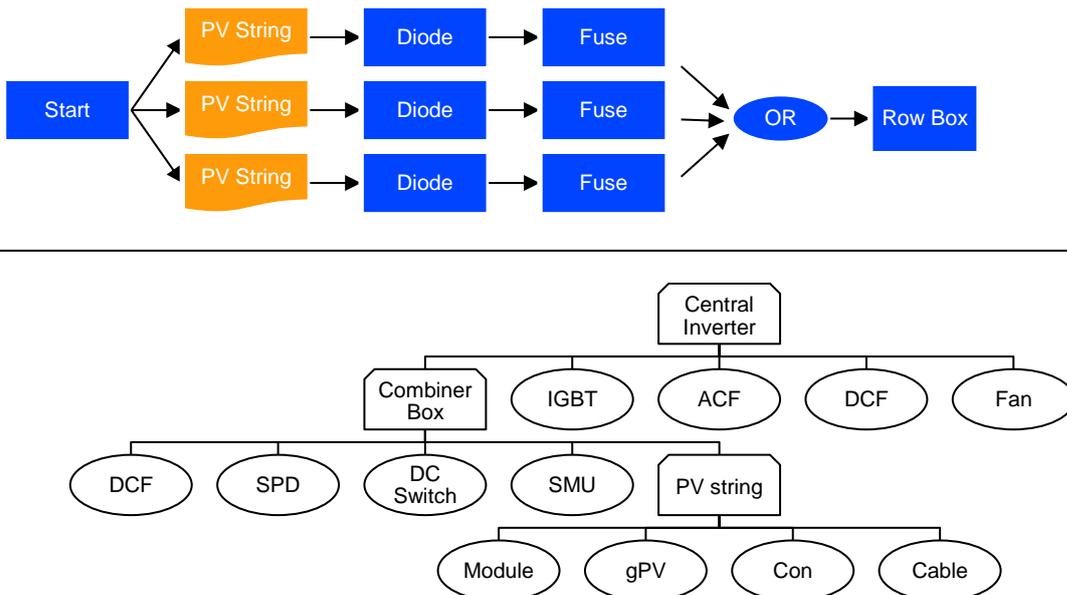
Figure 5: Examples of Reliability Block Diagram (TOP) and Fault Tree (BOTTOM). Adapted from [11].

Technical risk and the reliability of a component are complements of each other, as long as they cover the same sample space. In this context another widely used quantification method is the Reliability, Availability and Maintainability analysis. RAM analysis aims to identify any significant performance losses and then recommend improvements to the maintenance strategy. In this bottom-up approach a Reliability Block Diagram (RBD) or the Fault Tree Analysis (FTA) is recommended to determine the effects of the failure of individual components (Figure 5).

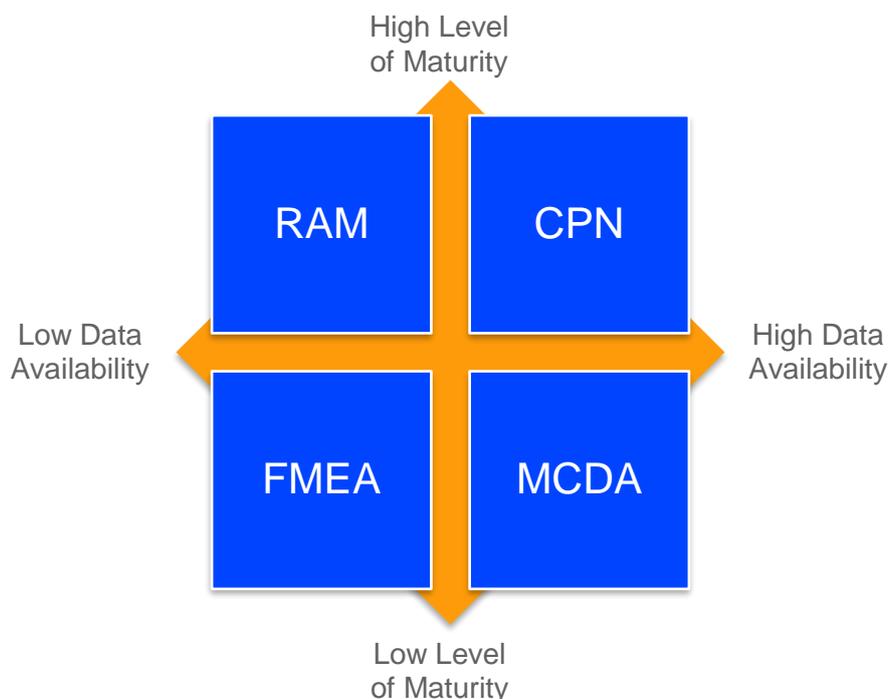
Figure 6: Selection guide of methods presented based on the driving-factors: data availability and level of technology maturity.

Choosing the best method for the individual purpose is rarely trivial. The advantages, and disadvantages of the presented methods are demonstrated considering the factors maturity level and data availability and are illustrated in Figure 6.

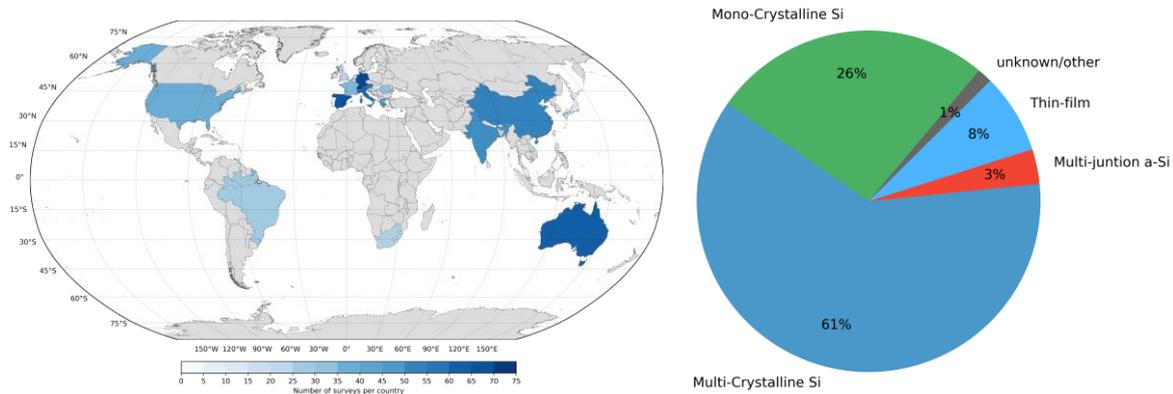
Figure 12: Left - Distribution of PV system locations in the data collection. Right - Distribution of PV module technologies in the data collection.

Unfortunately, many datasets were not complete so that we had to exclude a lot of data. Since the last failure data evaluation [1], we added 76 new complete PVDSs to the PV system data collection. The data collection consists of 226 PVDSs in total. An overview of the distribution of the PV systems and the analysed PV module technologies is given in Figure 12. Most data is from Europe. In total, data from all 6 continents are available. Although the market share of

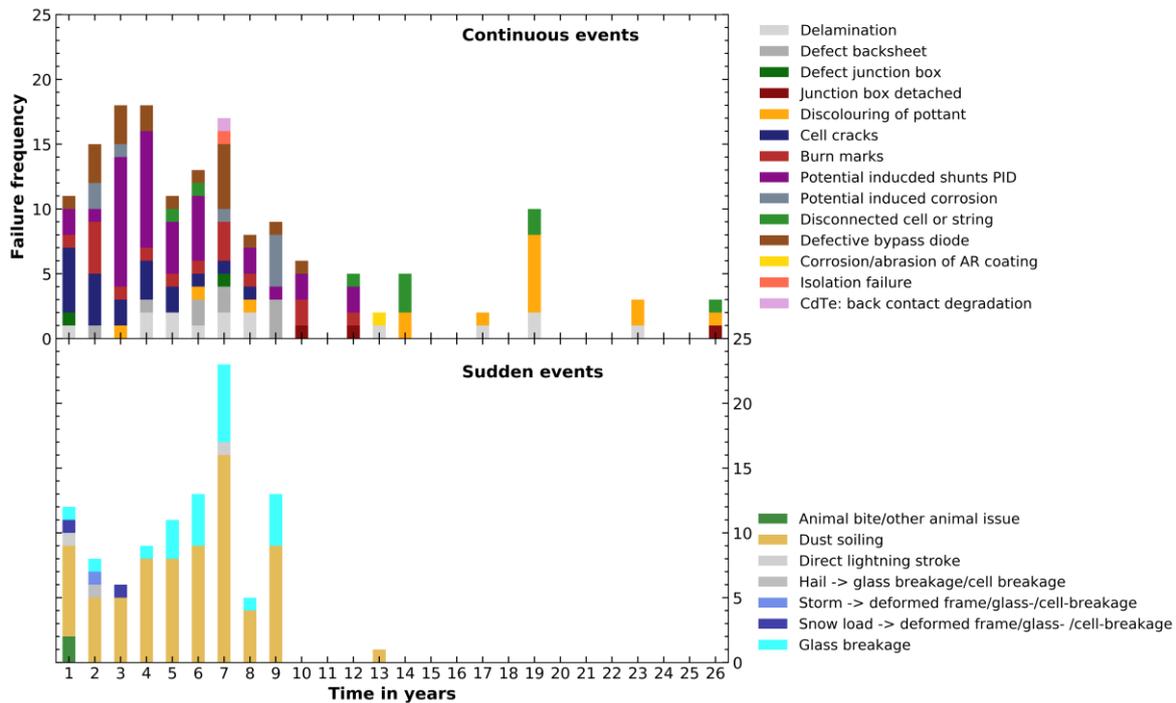
Figure 13: Failure frequency for PV module defects with an impact on the system power. The upper graph is showing PV module failure frequency with a slow degradation over time and the lower graph failure frequency for sudden events.

Figure 13 shows the frequency distribution for PV module failures with an impact on the power generation of the PV systems. The distribution is split into failures which lead to a degradation and sudden occurring failures. Most reports on failures with power loss are given in the first 10 years of operating time. This is to be expected as it is often too expensive to repair PV systems older than 10 years. Therefore, no detailed analysis is made. The main results of the last report “Assessment of Photovoltaic Module Failures in the Field” remain true. PID effects, cell cracks and defective bypass diode failures seem to dominate the failure statistic in the first seven years. This dominance now becomes even more pronounced in comparison with the statistics presented in [1]. Additionally, the failure type “burn marks” have been detected more frequently. For sudden events, also shown in Figure 13, the failure glass breakage and dust soiling fully dominate the failure statistic.

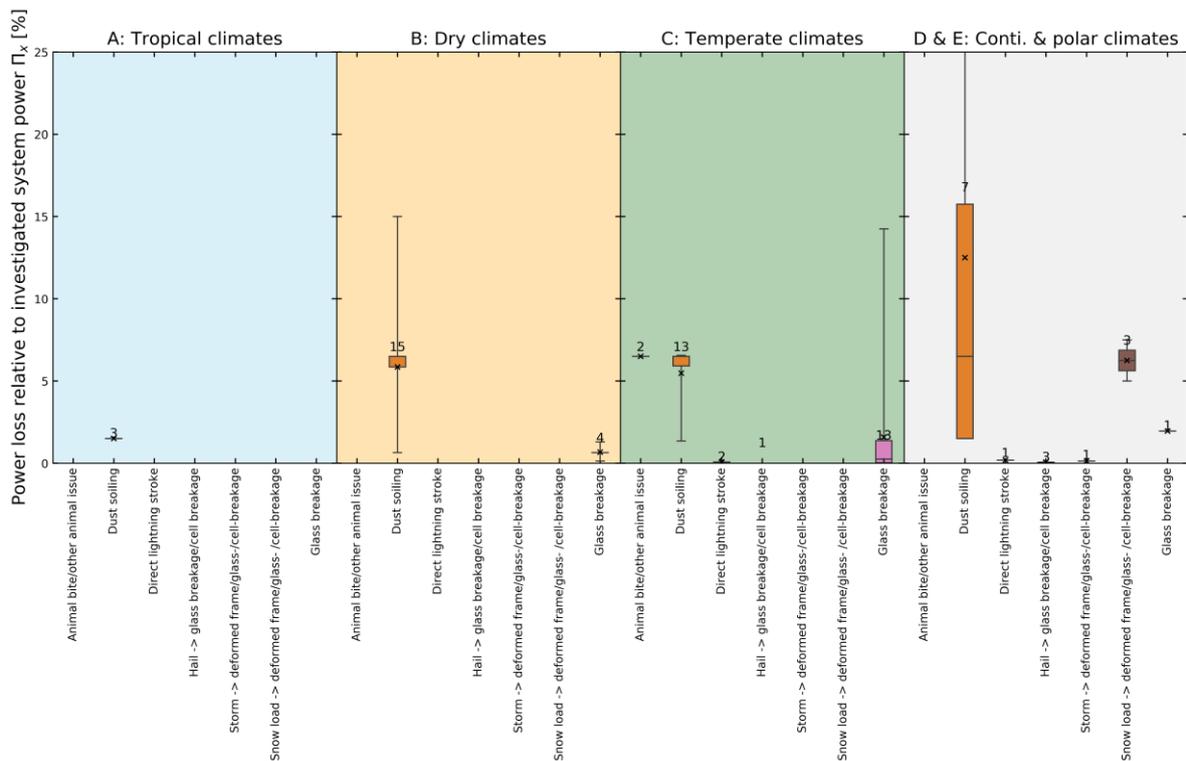
Figure 14: Power loss of sudden failure events on the total power of the PV system.

Figure 14 shows the power loss impact of sudden events on PV system performance. Documented glass breakage events lead in temperate climates to a loss of 1% to 2% of a system's power, with one exception in the dataset. These events seem to occur everywhere but appear to be not so severe for the whole system. Dust soiling appears everywhere except for tropical climates. In temperate climates, the impact is at a maximum 7% of the total system power whereas up to 15% power loss occurs in dry climates and over 25% for continental climates. As expected, the deformed PV module frame due to snow load occurs only in the continental and polar climate.

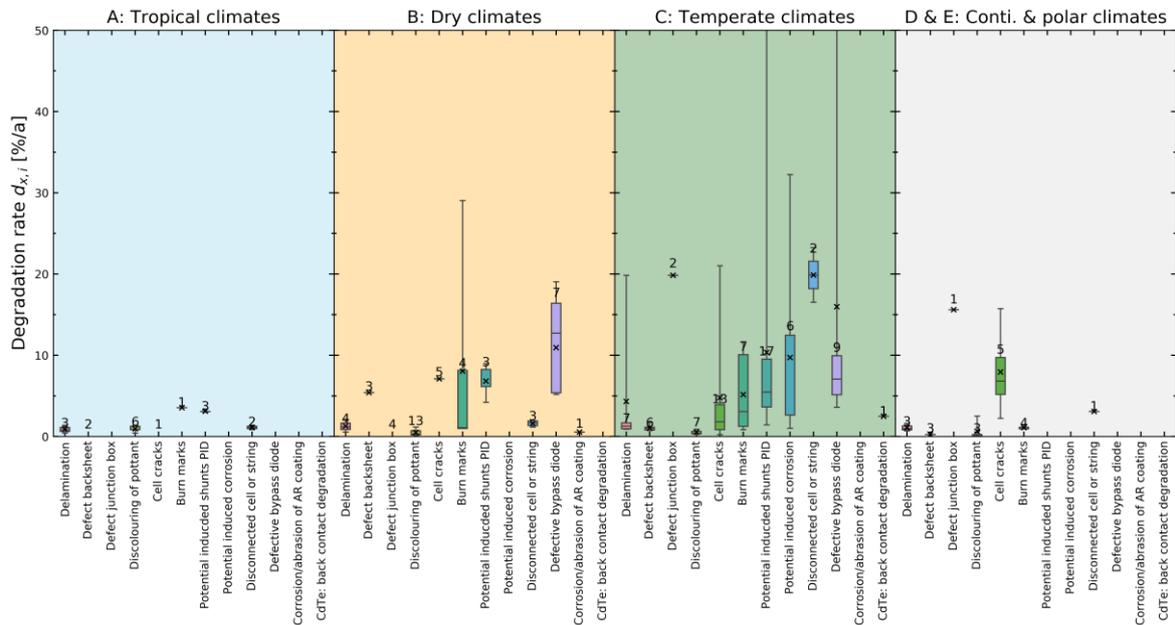
Figure 15: Box plot of degradation rates d_x of PV module affected by failures x sorted by climatic zones. The numbers show the quantity of data per failure in the database. The cross shows the mean degradation rate. The boxes include 50% of all values, the whisker show the full range of existing values. The middle line in the box shows the median.

Figure 15 and Figure 16 show the degradation rate for the affected system parts and the whole system for various failures sorted by climatic zones. The additional data supports the former statements for the degradation rates of the failure types in [1].

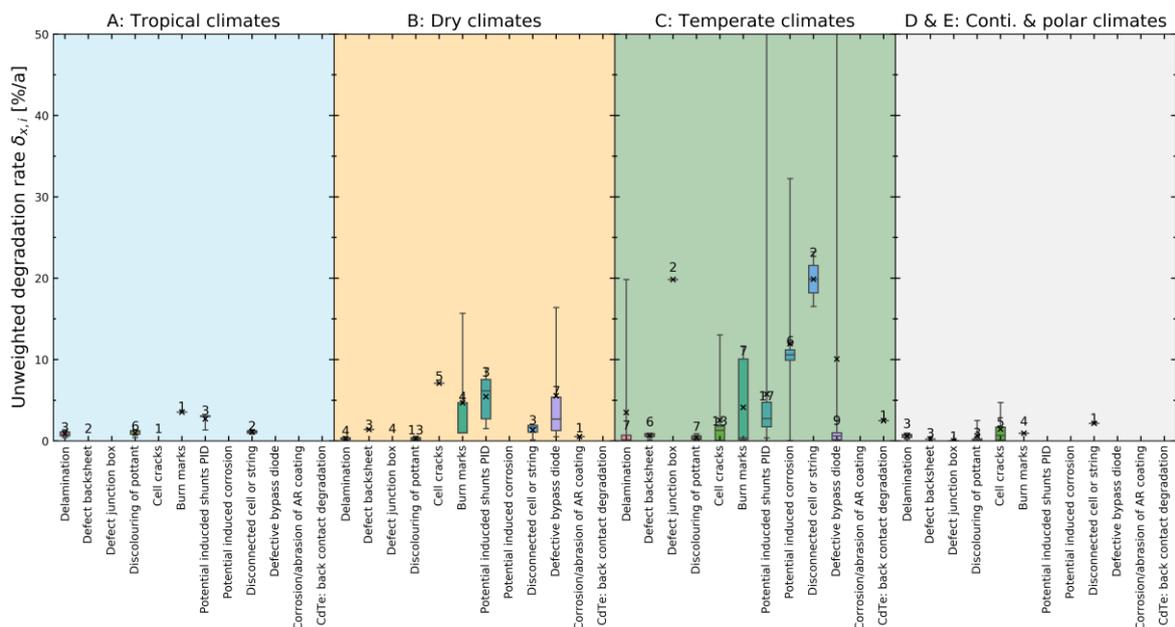
Figure 16: Degradation rates of the whole PV system sorted by climatic zones. The numbers show the quantity of data per failure in the database. The boxplot and the whisker have the same meaning as in Figure 15.

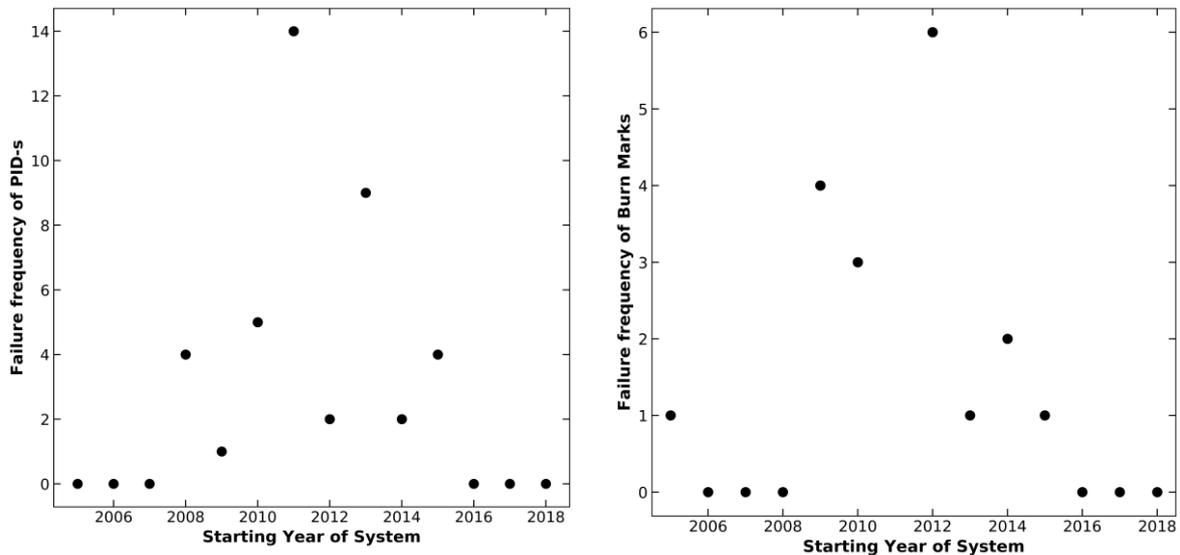
Figure 17: Left - Failure frequency of PID-s. Right – Burn mark cases in the base data as function of the installation time of the system.

A common effect is that new and unexpected failures types occur in the field. After they are recognised, understood and tests are developed, the failure type vanishes in the field because the manufacture can develop their products defect free. The PID-s and burn mark effect, shown in Figure 17, are good example for such a cycle. The first PID-s reports are for PV systems installed in 2008. In 2016, after 8 years, we have no more reports on PID-s failures in the field in the data collection. The burn mark defects show a similar trend.

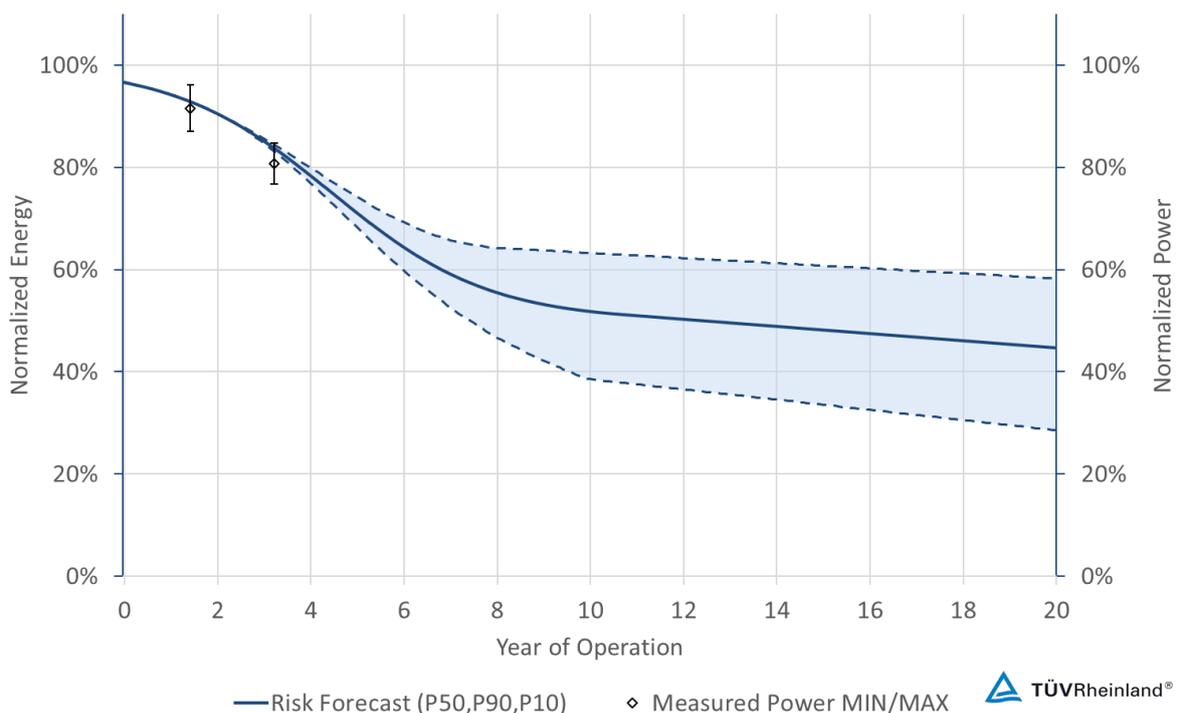
Figure 18: Energy forecast of No-Mitigation Scenario.

Taking the behaviour of the identified root cause into account, the potential future PLR is expected to increase further with an expected saturation of 50%. After this value is reached, the PLR is expected to stagnate at a constant level of 0.7% per year. This prediction of performance development for 20 years of operation is shown together with the exceedance probability P10 and P90 for a confidence level of 68.2% in Figure 18. Taking CAPEX, OPEX and annual revenues into account, the project's financial profit after 20 years of operation is 48% below original expectations for the defined scenario without mitigating actions.

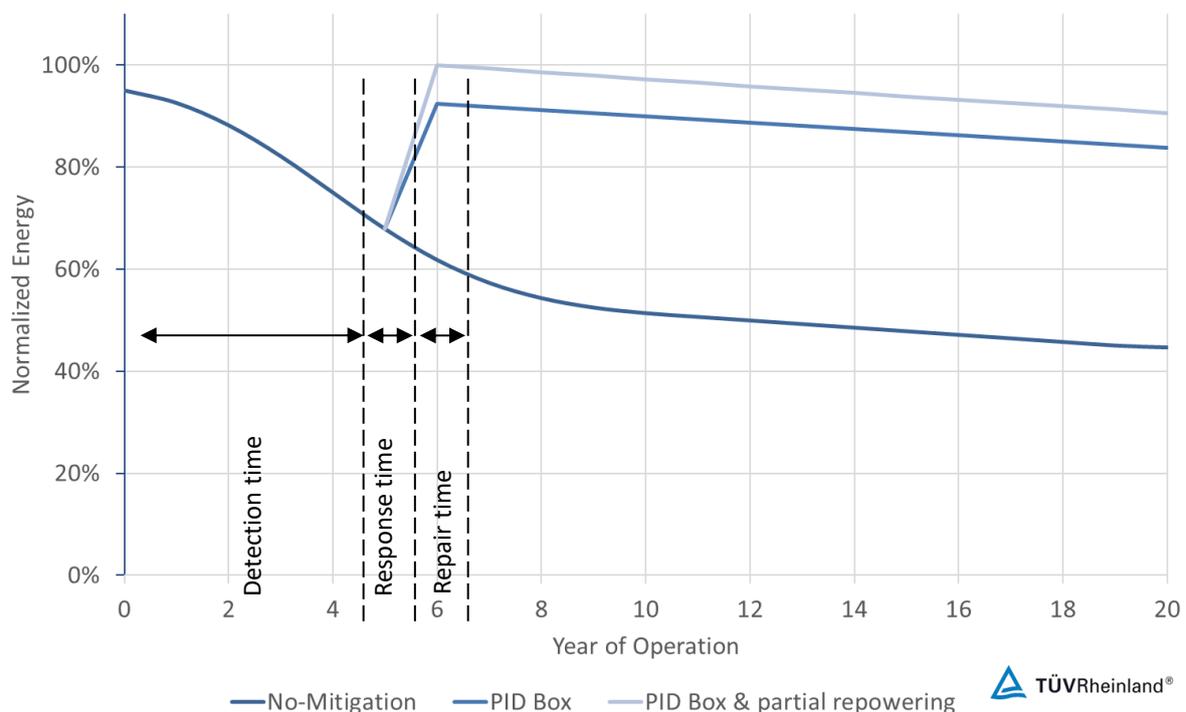
Figure 19: 20-year forecast for three mitigation scenarios; the repowering is carried out with a higher module power class.

The expected annual production of energy yields for the three scenarios is illustrated in in Figure 19. After the mitigation measures were applied in year 5 of the operation, the energy yields show a steep rise. The expected PV plant output after 20 years of operation is calculated at 45% rated energy output for the no-mitigation scenario and at 84% and 91% for mitigation options 1 and 2, respectively.

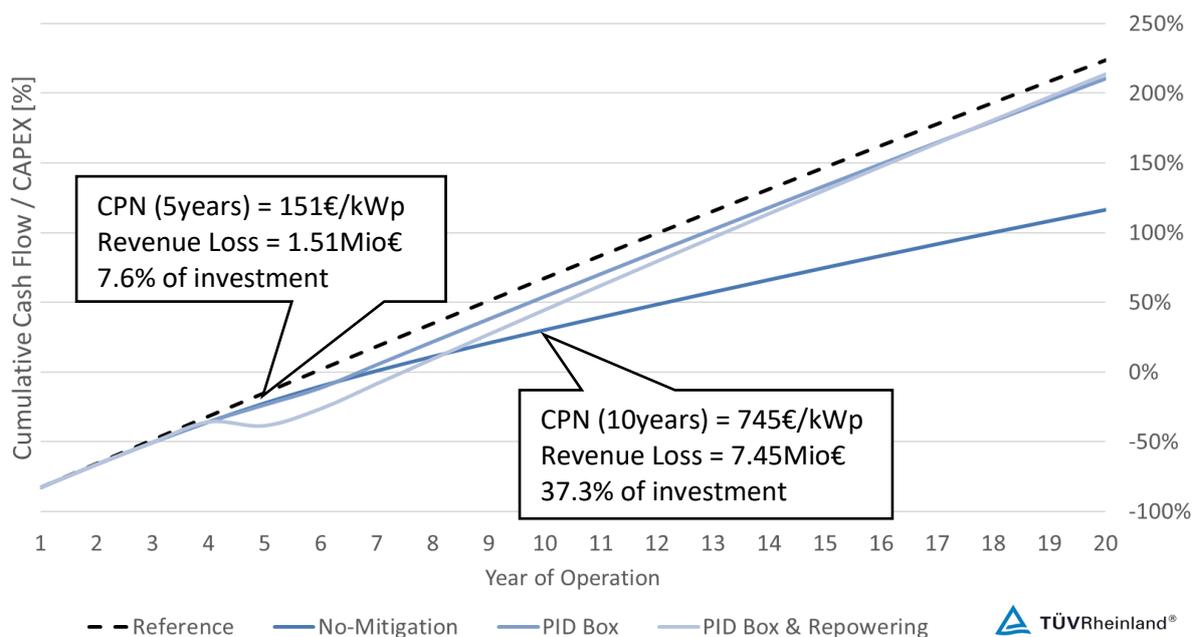
Figure 20: Annual cumulative cash flow of the mitigation scenarios with CPN and loss of revenue after 5 and 10 year of operation if no action is taken.

The cost-benefit analysis also takes the associated costs of the available options into account, as described in Table 14. The impact on the annual cash flow is demonstrated in Figure 20. In the reference scenario, the monetary yield of the PV project after 20 years is expected to be around 225% of the CAPEX (dashed line). If no mitigation measures are taken, the lowest result of around 115% of CAPEX is forecasted. Mitigation options 1 and 2 result in 6.0%, respectively 4.6% below expectations, which both represent successful projects results. It can be concluded that both mitigation options should be considered and taken as a solution compared to non-action. However, the additional investments in year 5 of operation for option 2 are significantly higher by a factor of 8.

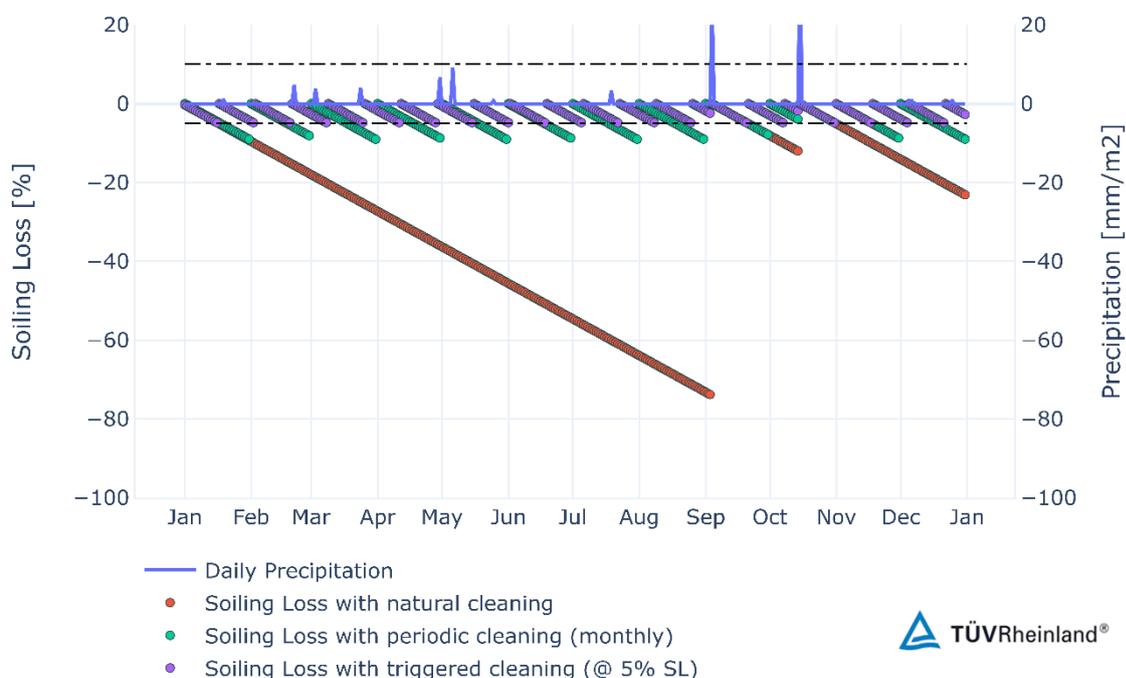
Figure 21: Impact of cleaning routines on soiling losses of a 10 MWp plant in Abu Dhabi.

Cleaning routines for PV power systems in desert regions are a typical corrective measure to reduce energy yield losses due to soiling. The impact of different cleaning procedures on the soiling losses over one year are calculated and shown in Figure 21 for a 10 MWp PV plant near Abu Dhabi [59]. The soiling rate is 0.3%/day and only two significant precipitation events are recorded during one year. If no cleaning (natural cleaning) is performed, soiling losses (brown bars) may reach up to 30% per year and result in annual costs of 2614 k\$ (Table 12).

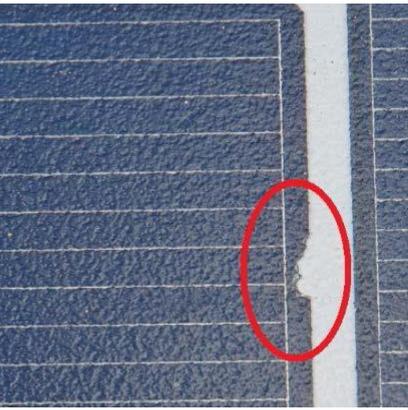
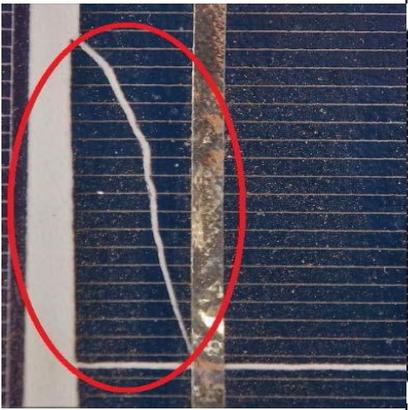
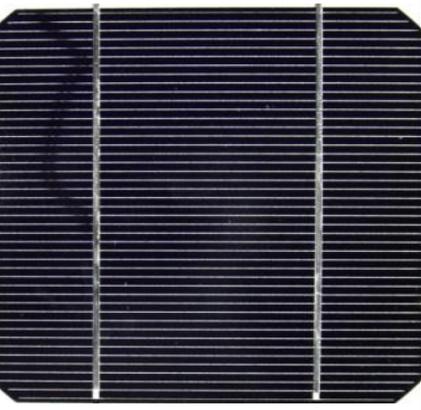
EXAMPLES (page1)		PVFS 1-1vs.01	
Examples 1-3

Cell chipping. A very small region is missing from the edge of the cell, but does not enter metalized region. [16]	Large crack at cell corner visible by eye - small portion of the cell (<10%) is no longer electrically connected. [16]	Cell crack with snail track. No isolation of any cell part. The propagation could isolate a cell area >10%. [16]
Severity

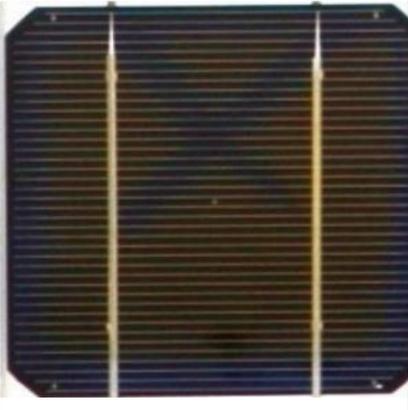
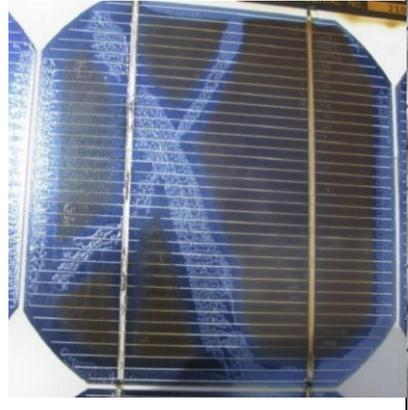
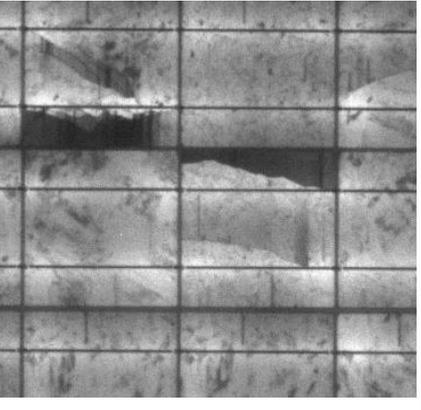
Examples 4-6

Cell cracks visible by the photo-bleaching effect. This may not be mistaken for snail tracks. [16]	Two cell cracks with extensive delamination, EVA browning and photo bleaching. [41]	EL image of 2 cell cracks which isolates more than 10% of the cell area. [TUV Rheinland]
Severity

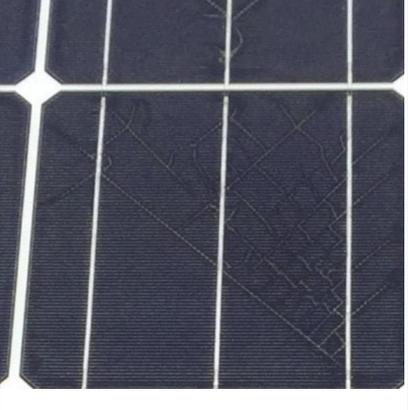
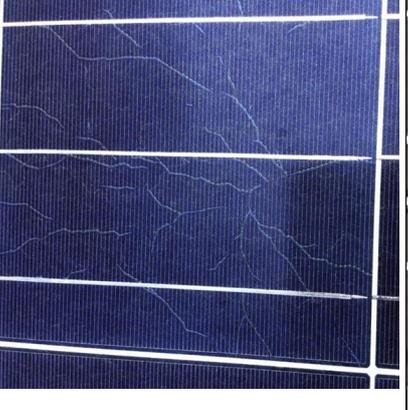
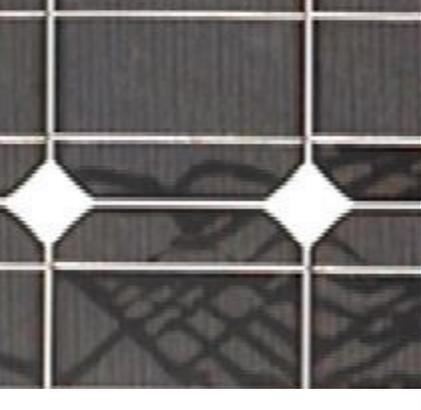
Examples 7-9

Snail track example. [41]	Snail track example. [41]	EL of cell cracks with snail tracks. [16]

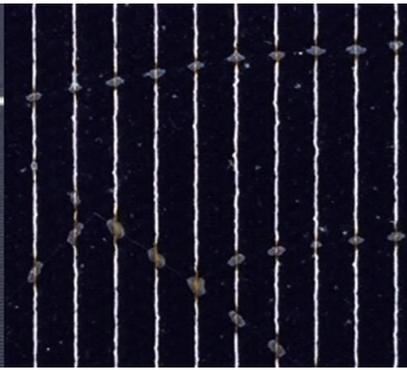
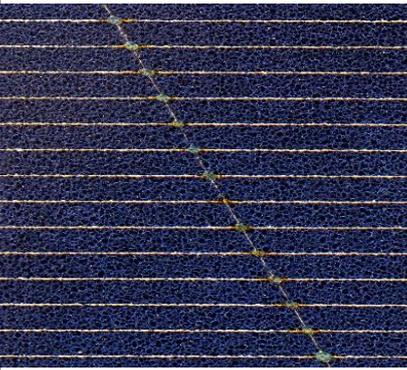
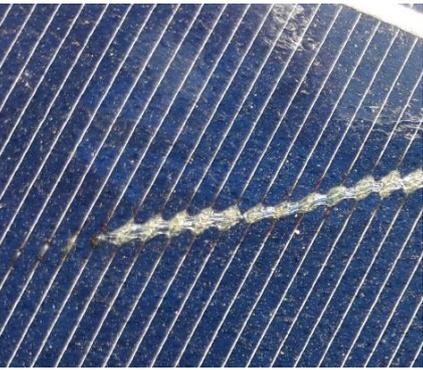
EXAMPLES (page2)		PVFS 1-1vs.01	
Examples 10-12

Zoom of snail track with delamination. [41]	Zoom of snail track with browned fingers. [37]	Zoom of snail track with delamination. [SUPSI]
Severity

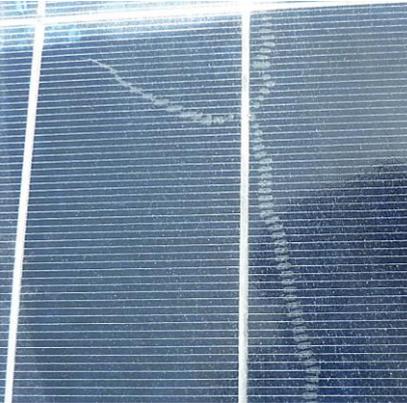
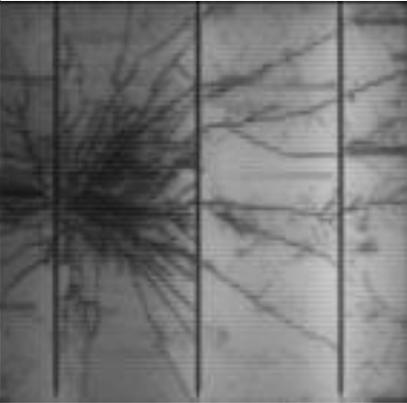
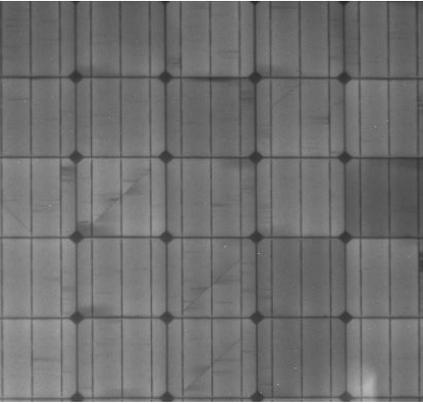
Examples 13-15

Cell crack with EVA delamination. [TUV Rheinland] (see also PVFS 1-3)	Typical EL picture of a cell crack caused by hail. [TUV Rheinland]	Repetitive crack pattern due to impact of soldering machine. [SUPSI]
Severity

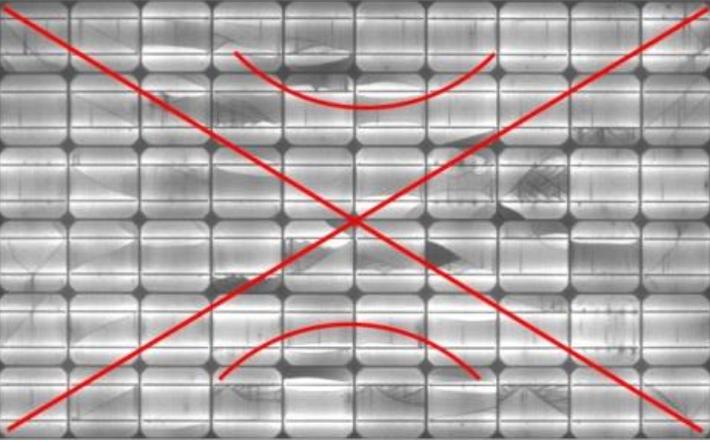
Examples 16

Typical EL picture of cell cracks caused by a heavy homogeneous mechanical load (X-crack pattern) also without glass breakage. [16]		
Severity

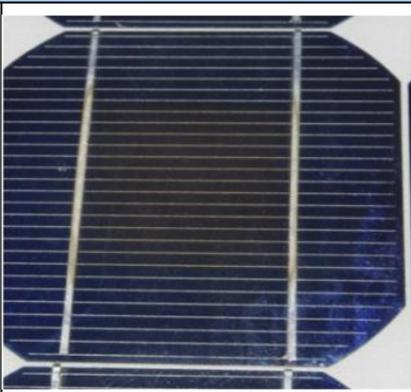
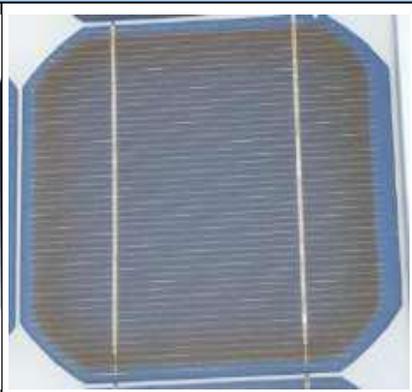
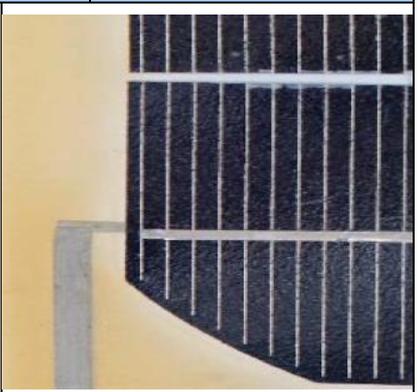
<p>Examples 1-3</p>

<p>Slightly browned EVA in the centre of the cell with photobleaching at the edges. [16]</p>	<p>Slightly browned EVA in the centre of the cell with photobleaching at the edges. [44]</p>	<p>Yellowed backsheet from the inside. [37]</p>			
<p>Severity</p>

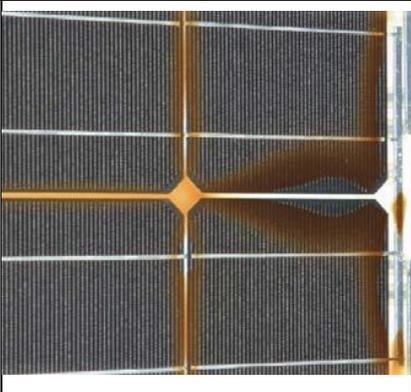
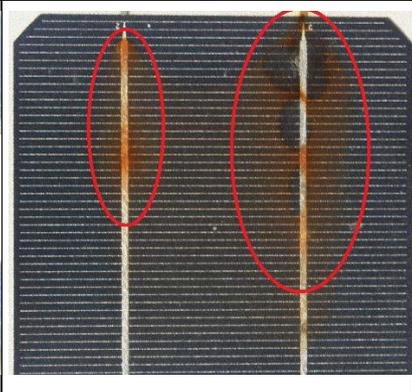
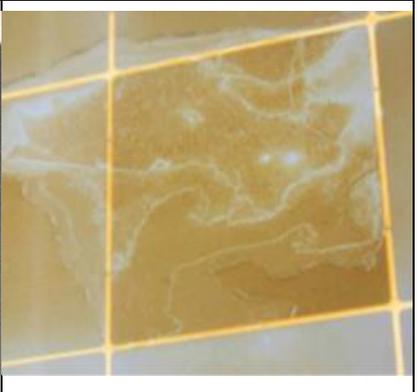
<p>Examples 4-6</p>

<p>Dark discoloration at cell edges, between cells and over gridlines and busbars. [37]</p>	<p>Dark discoloration over metalization. [37]</p>	<p>Backsheet air side yellowing. [37]</p>			
<p>Severity</p>

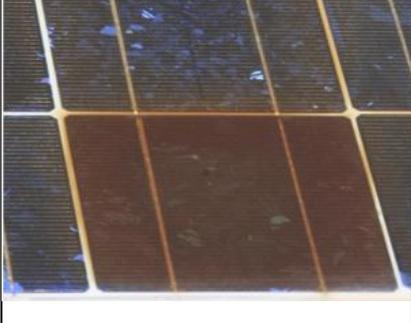
<p>Examples 7</p>

<p>Single cell browned much faster than the others due to local heating. [16]</p>					
<p>Severity</p>

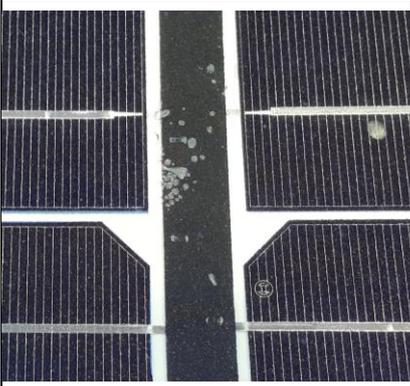
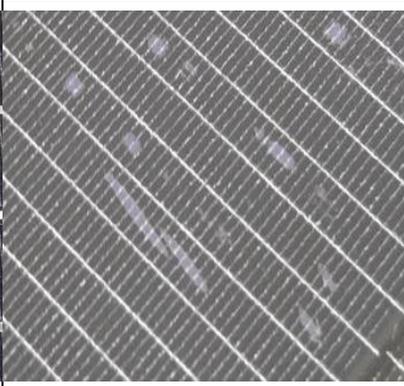
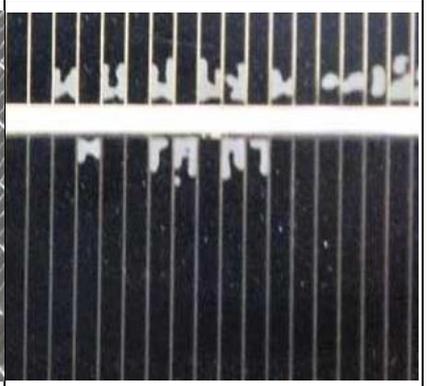
<p>Examples 1-3</p>

<p>Encapsulant delamination in un-critical position. [SUPSI]</p>	<p>Encapsulant delamination from cell caused by production process. [SUPSI]</p>	<p>Encapsulant delamination from cell along grid fingers and bus bar. [38]</p>			
<p>Severity</p>

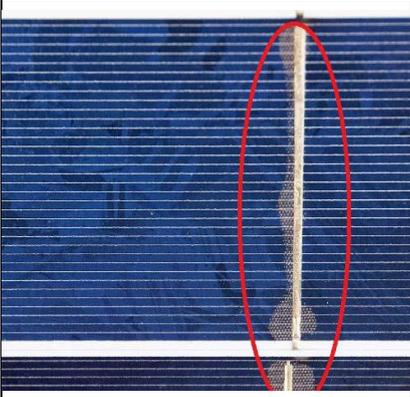
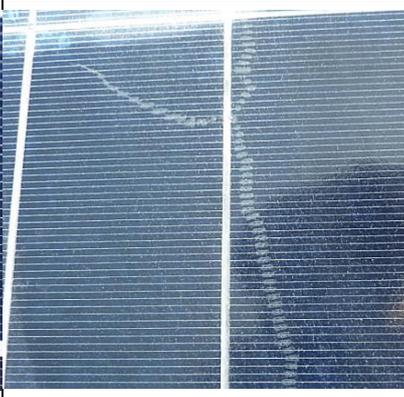
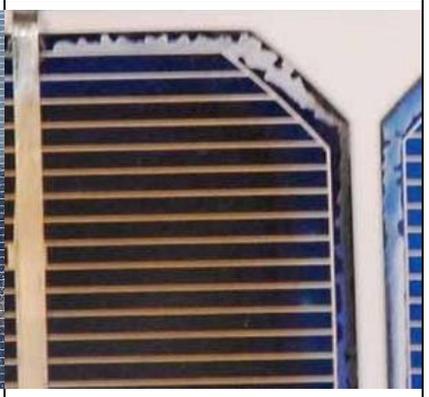
<p>Examples 4-6</p>

<p>Encapsulant delamination from glass (spotted due to glass texture) along the bus bars. [37]</p>	<p>Encapsulant delamination along a cell crack. [46] (see also PVFS 1-1)</p>	<p>Encapsulant delamination near cell edges in combination with cell browning. [38]</p>			
<p>Severity</p>

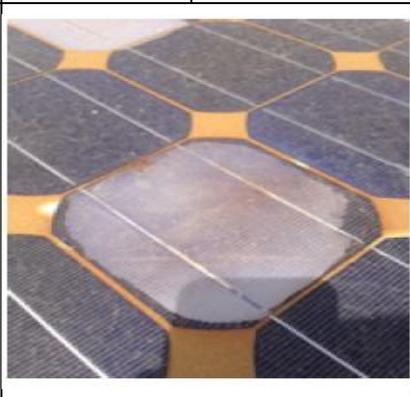
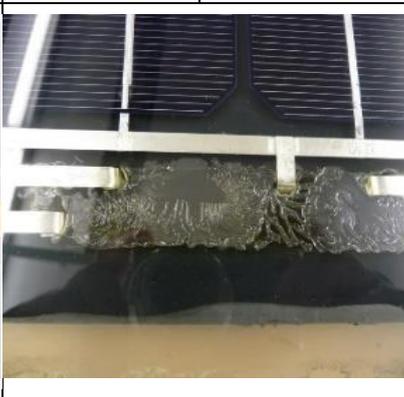
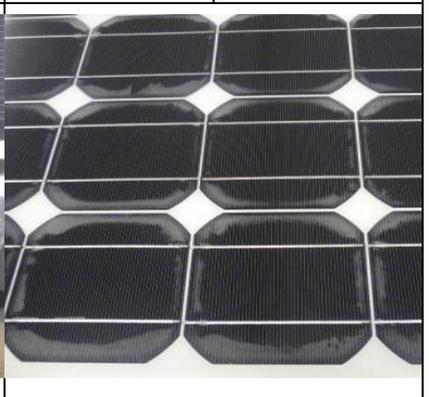
<p>Examples 7-9</p>

<p>Delamination in front of cell in the centre of the module. [40] (see also FS 1-2)</p>	<p>Delamination at module insert connections of a glass/glass module (junction box). [SUPSI]</p>	<p>Delamination at cell edges. [16]</p>

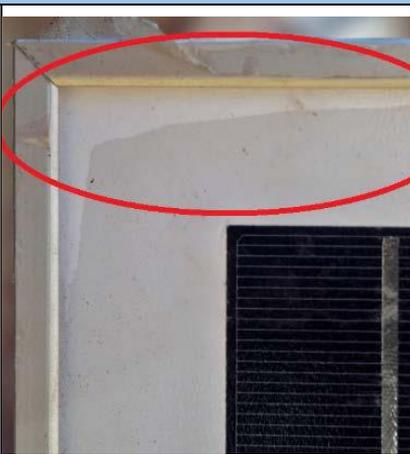
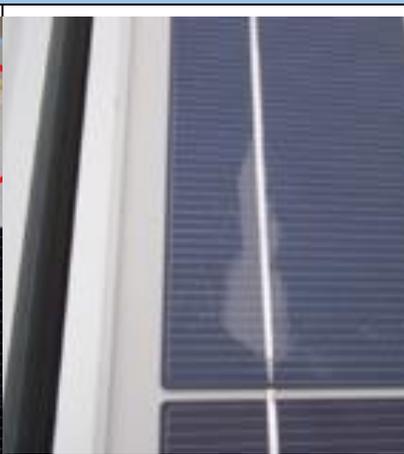
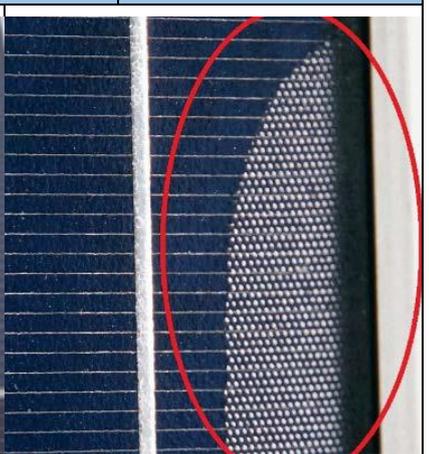
<p>Examples 10-12</p>

<p>Encapsulant delamination at borders. [37]</p>	<p>Encapsulant delamination along a bus-bar in a cell close to the module edge. [40]</p>	<p>Encapsulant delamination of from glass (spotted due to glass texture) at the edge of the cell. [37]</p>
<p>Severity</p>

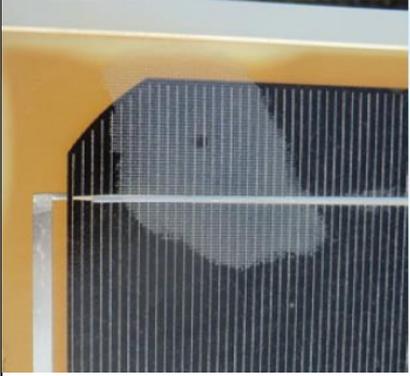
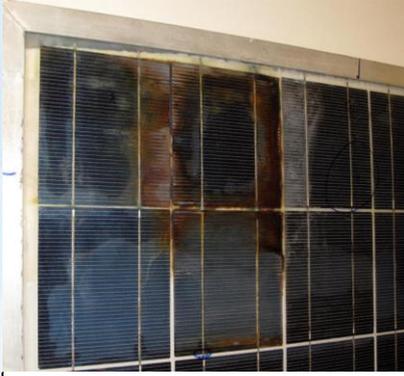
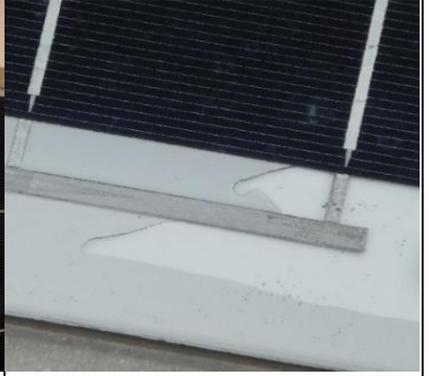
<p>Examples 13-15</p>

<p>Delamination creating a continuous path between electric circuit and the edge. [40]</p>	<p>Delamination with corrosion. [1] (see also FS1-11)</p>	<p>Delamination caused by detachment of backsheet with exposure of encapsulant from the back. [SUPSI]</p>
<p>Severity</p>

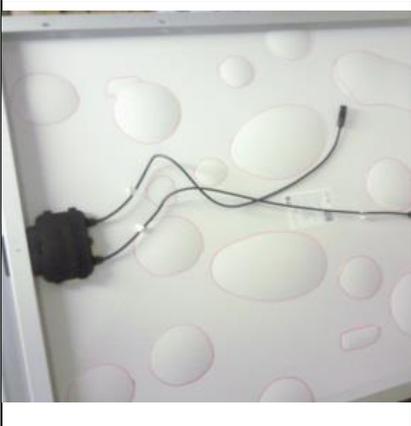
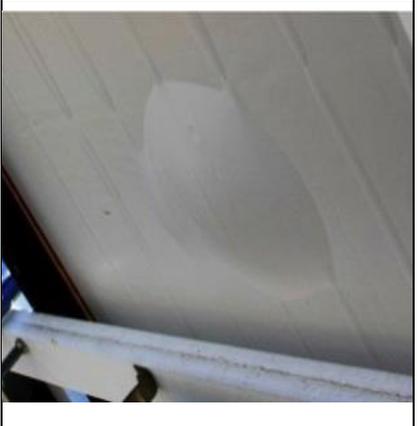
<p>Examples 1-3</p>

<p>Multiple bubbles in the centre and edge of the backsheet. [46]</p>	<p>Blisters because of vapour barrier, such as aluminium foil. [1]</p>	<p>Big central bubble + wavy delamination. [16]</p>			
<p>Severity</p>

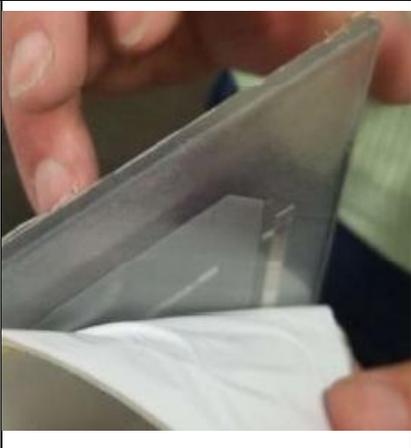
<p>Examples 4-5</p>

<p>Backsheet delamination with direct exposure of encapsulant. [SUPSI]</p>	<p>Delamination of top layer without exposure of encapsulant. [SUPSI]</p>				
<p>Severity</p>

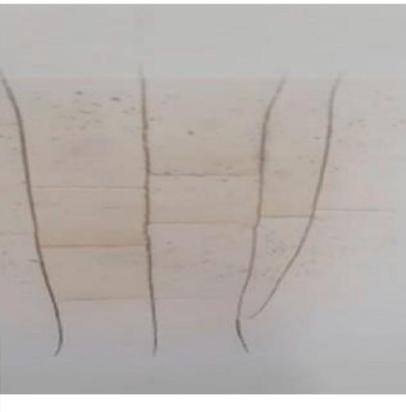
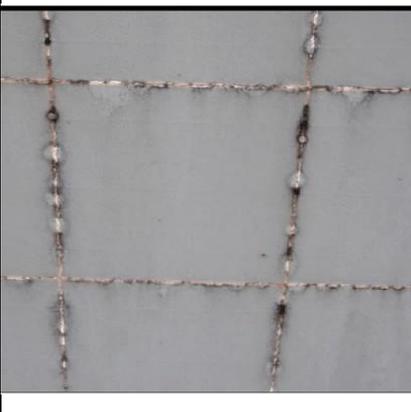
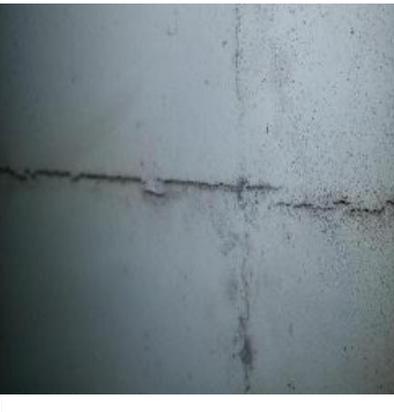
<p>Examples 1-3</p>

<p>Cracked backsheet in combination with yellowing under a hot cell. [39]</p>	<p>Squared cracks beneath cell interspaces. [39]</p>	<p>Cracking between cells. [38]</p>			
<p>Severity</p>
