Task 13 Performance, Operation and Reliability of Photovoltaic Systems

Quantification of Technical Risks in PV Power Systems

2021

Report IEA-PVPS T13-23:2021
February 2022

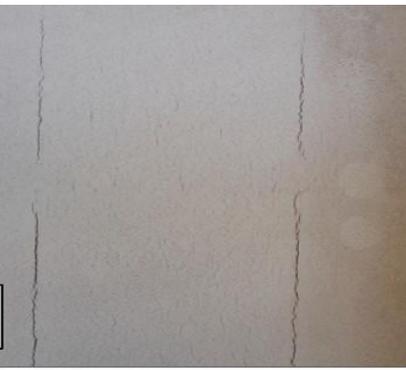
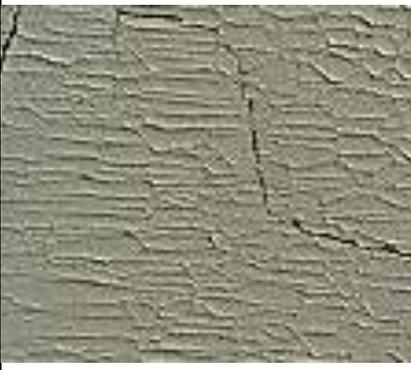
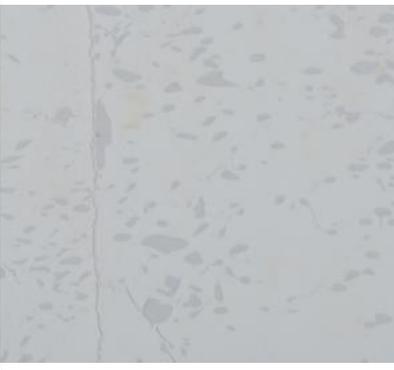
<p>Examples 4-6</p>

<p>Longitudinal cracks located under bus bars. [39]</p>	<p>Backsheet cracking. [57]</p>	<p>Backsheet cracking. [57]</p>			
<p>Severity</p>

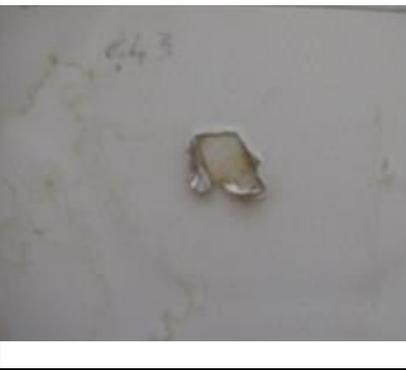
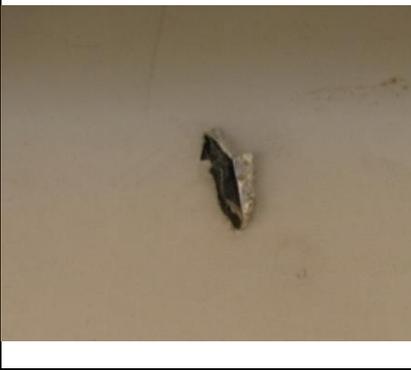
<p>Examples 7-8</p>

<p>Localized superficial damage. [1]</p>	<p>Deep scratch on backsheet. [TUV Rheinland]</p>				
<p>Severity</p>

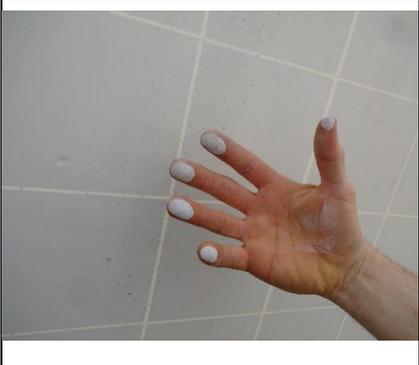
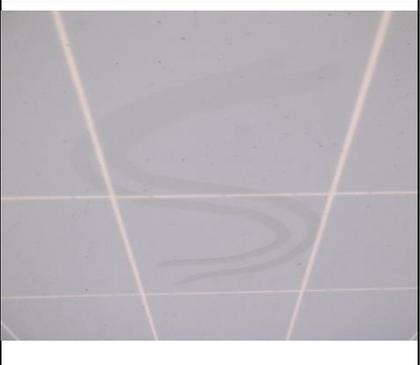
<p>Examples 1-2</p>

<p>Finger with white powder. [TUV Rheinland]</p>	<p>Fingerprint on a module with chalking. [TUV Rheinland]</p>				
<p>Severity</p>

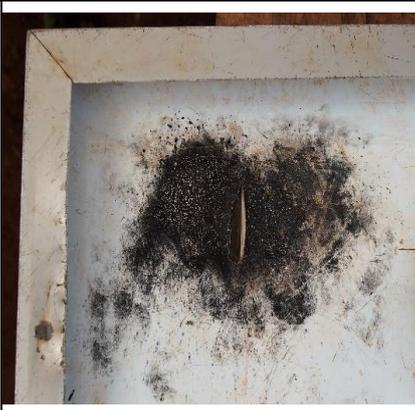
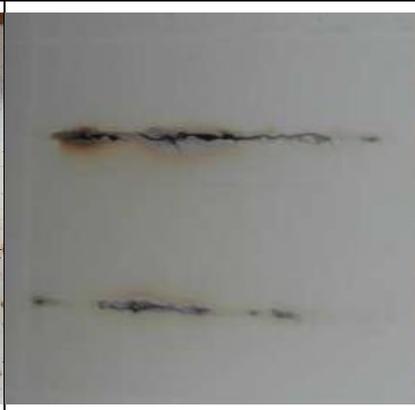
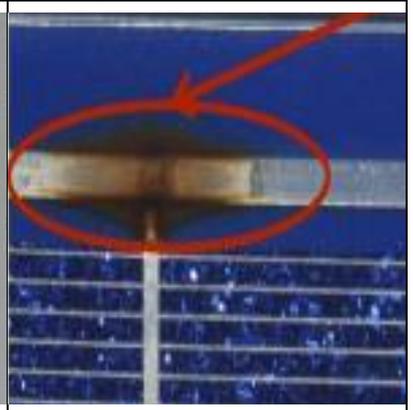
<p>Examples 1-3</p>

<p>Burn mark at the backsheet with cracked backsheet. [37]</p>	<p>Burn marks at the backsheet due to heating along a busbar. [16]</p>	<p>Burn mark associated with overheating along the metallic interconnection (without backsheet damage). [16]</p>
<p>Severity</p>

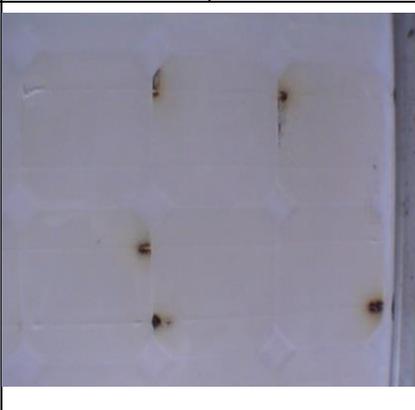
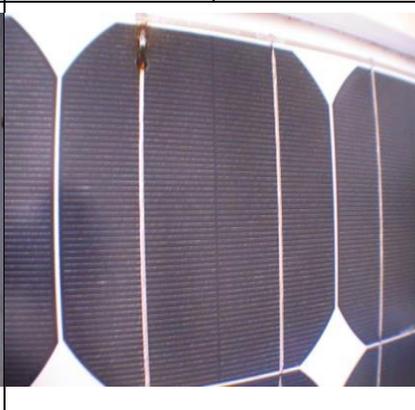
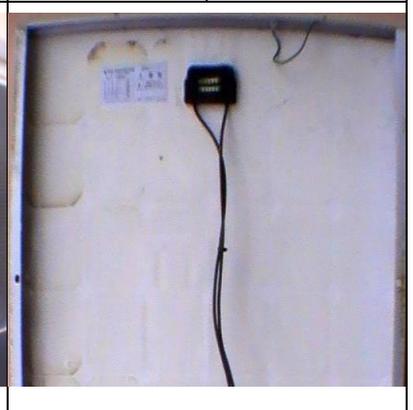
<p>Examples 4-6</p>

<p>Front and back side view of burn marks caused by open-circuited bypass diodes and current mismatch conditions (due to shading or cracked cells). [16]</p>		<p>Burn marks caused by defect bypass diodes or an interconnect failure in the junction box. [16]</p>
<p>Severity</p>

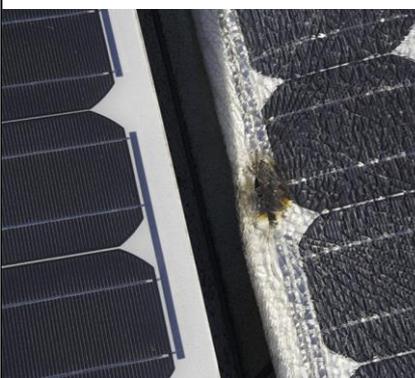
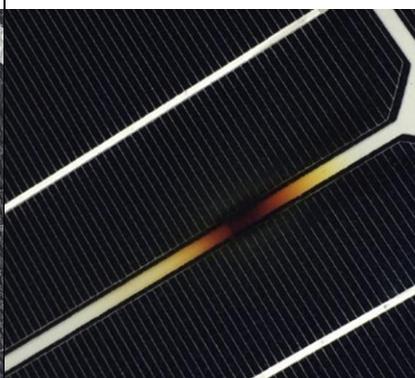
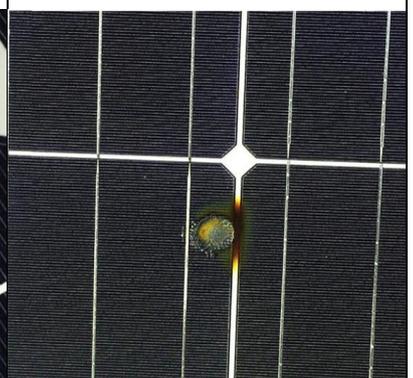
<p>Examples 7-9</p>

<p>Burn mark with broken glass caused by poor bussing ribbon soldering. [41] (s. also PVFS 1-8 and PVFS 1-8)</p>	<p>Burn mark due to intrinsic shunting caused by error in manufacturing process. [41]</p>	<p>Burn mark due to intrinsic shunting caused by error in manufacturing process. [41]</p>

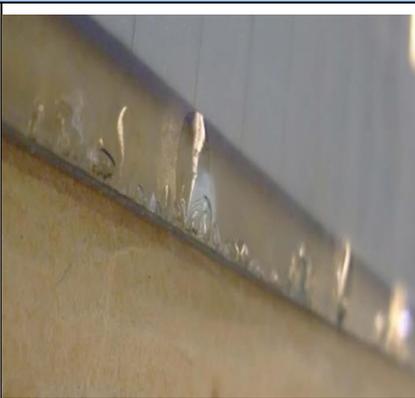
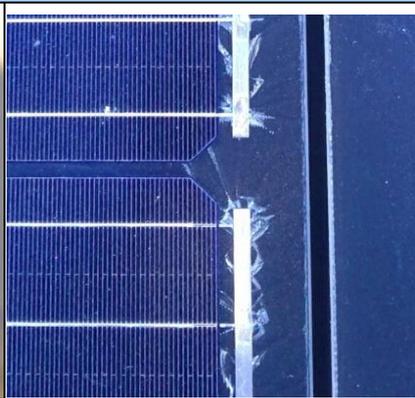
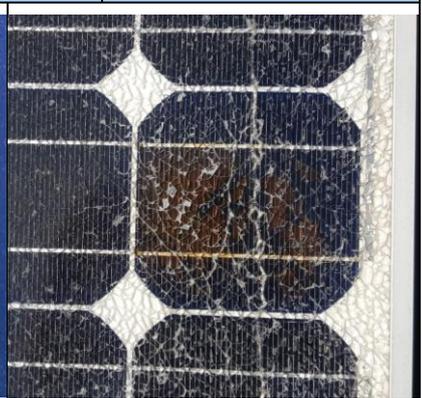
<p>Examples 1-3</p>

<p>Chipped glass at the corner. [38]</p>	<p>Glass breakage along the string interconnect ribbons due to weak manufacturing process. [SUPSI]</p>	<p>Glass breakage of tempered glass induced by a hot-spot. [SUPSI]</p>
<p>Severity</p>

Component Defect	Module	PVFS 1-8vs.01	
Appearance	Glass is cracked locally or over the full area of the module. Glass breakage looks different depending on the type of glass and the origin of the glass breakage. Tempered glass or heat-treated float glass will shatter into small pieces, whereas annealed glass breaks into big pieces. Heat-treated glass stays in between.		
Detection	VI, IRT		
Origin	Glass breakages of the front glass can be caused by heavy impacts such as hail or stones or other extreme mechanical stress onto the module frame due to external stresses or bad mounting. High temperatures (hot-spot or arc) can also break the glass. Annealed glass breaks also due thermal gradients or stress induced by the lamination process or cleaning of the modules. A relatively often seen failure in the field is glass breakage of frameless PV modules caused by the clamps. Glass/glass modules are more sensitive to glass breakage. The origin of the failure is, on the one hand, at the planning and installation stage either (a) poor clamp geometry for the module, e.g. sharp edges, (b) too short and too narrow clamps or (c) the positions, kind or number of the clamps on the module not being chosen in accordance with the manufacturer's manual. The second origin which induces glass breakage could be excessively-tightened screws during the mounting phase or badly-positioned clamps. The glass of some PV modules may also break due to vibrations and shocks occurring during transportation or handling. Another reason for glass breakage comes from impact stresses on the glass edge. Sometimes vandalism or animal damage happens, the animals like goats like to climb on the PV modules, and birds may drop stone or other objects from the sky.

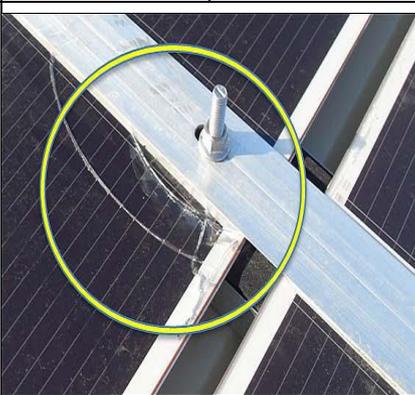
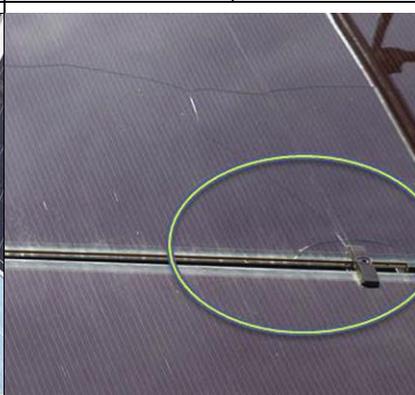
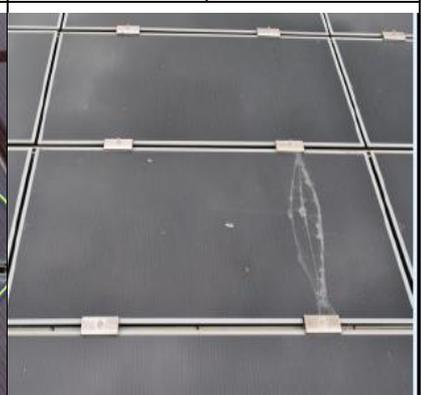
<p>Examples 4-6</p>

<p>Glass breakage caused by too tight screws. [16] (see also PVFS 3-1)</p>	<p>Glass breakage caused due to poor clamp design. [16]</p>	<p>Glass breakage caused due to poor clamp design. [1] (see also PVFS 3-1)</p>
<p>Severity</p>

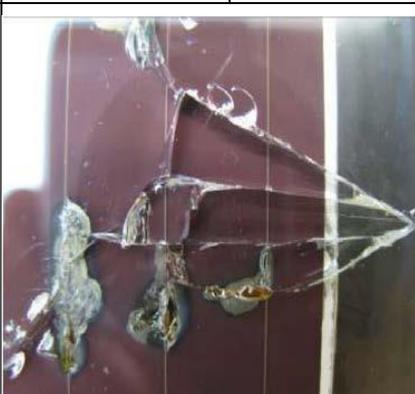
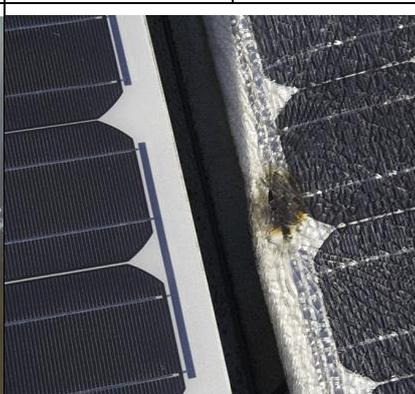
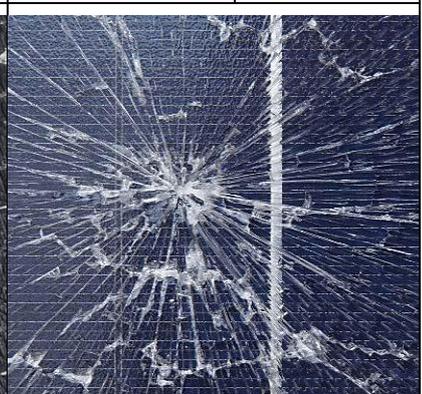
<p>Examples 7-9</p>

<p>Glass breakage through high temperature gradient and not tempered glass. [16]</p>	<p>Glass breakage of tempered glass induced by burn mark. [1] (see also PVFS 1-7 and PVFS 1-9)</p>	<p>Breakage of tempered glass. [1]</p>
<p>Severity</p>

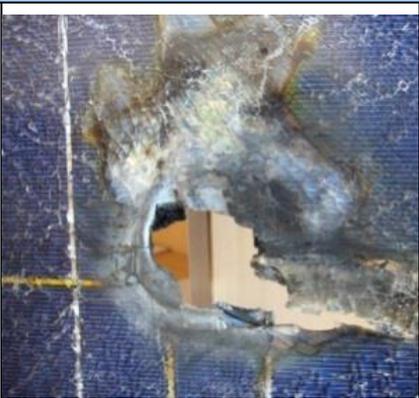
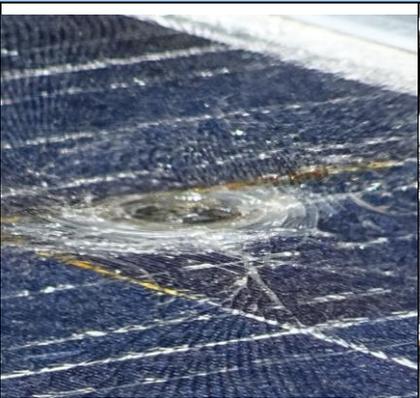
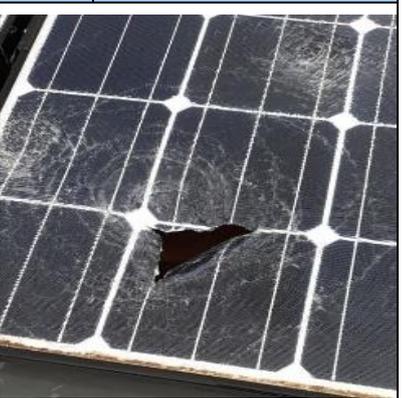
<p>Examples 10-12</p>

<p>Direct lightning stroke. [46]</p>	<p>Impact damage caused by a heavy object. [SUPSI]</p>	<p>Hail damage. [SUPSI]</p>
<p>Severity</p>

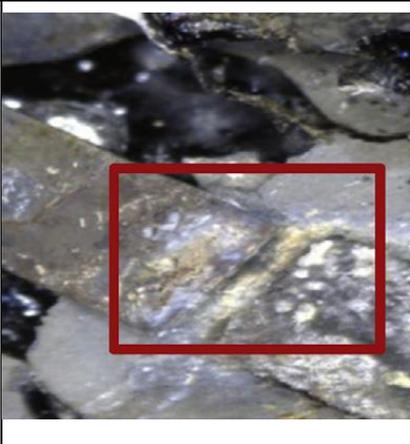
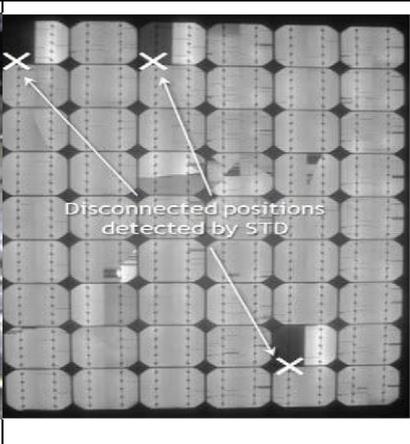
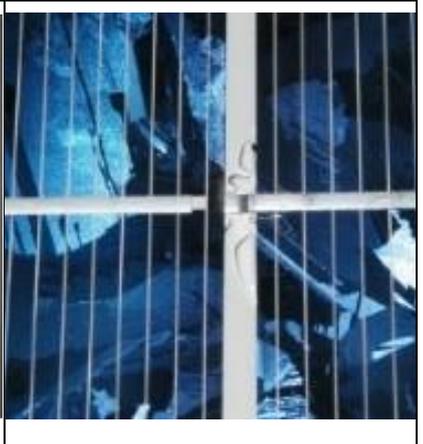
<p>Examples 1-3</p>

<p>Zoom of a broken cell interconnect. [41]</p>	<p>EL image of a module with 3 cells with disconnected interconnect ribbons. [16]</p>	<p>Disconnected cell interconnect with delamination. [1]</p>			
<p>Severity</p>

Component Defect	Module	PVFS 1-9vs.01	
Appearance	Weak or broken cell or string interconnection are not easy to see by the naked eye. The failure can be identified as dark region in the electroluminescence image where the failed interconnect would otherwise be collecting carriers or as a hot spot in the infrared image. In a progressed stage burn marks and glass breakage can occur.		
Detection	EL, IRT, STM, (VI)		
Origin	Typically, it is caused by the manufacturing process (e.g. poor soldering, misplacement of ribbons, too intense deformation of the ribbon kink, narrow distance between the cells) followed by thermomechanical stress or repetitive wind load caused by the outdoor operating environment. Electrochemical corrosion can be another cause for the degradation of interconnections.		
	Production <input checked="" type="checkbox"/>	Installation <input type="checkbox"/>	Operation <input checked="" type="checkbox"/>

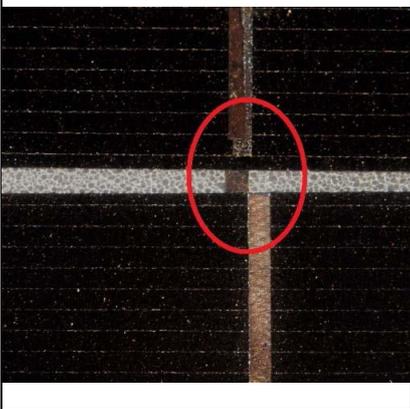
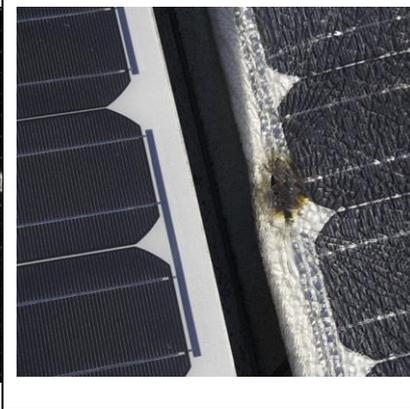
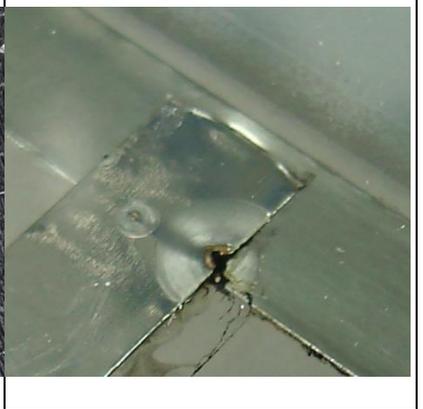
<p>Examples 4-6</p>

<p>Dislocation of interconnection ribbon. [37]</p>	<p>Poor soldering of string interconnect leading to burn mark and broken glass. [41] (see also PVFS 1-7 and PVFS 1-8)</p>	<p>Micro arc which occur if the conductive glue on the string interconnect has an insufficient contact. [16]</p>			
<p>Severity</p>

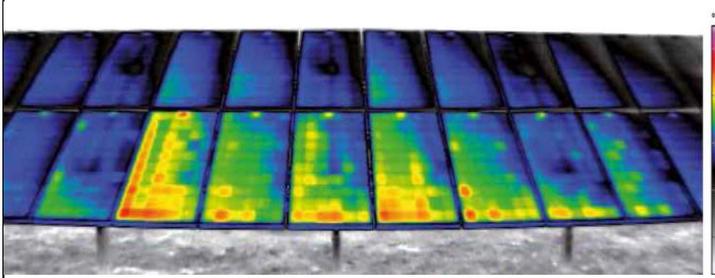
Strings with PID, detected with IR thermography. [16]

Component Defect	Module Potential induced degradation (PID) (page1)	PVFS 1-10vs.01
Appearance	<p>A potential induced degradation (PID) is not directly visible by eye. It is recognisable as an overtime increasing power loss, which is easily observable only a few years after installation. Infrared thermography (IRT) imaging of operational PV modules in the direct sunlight is the most straightforward method for getting the evidence of PID degradation. Typical PID IRT patterns (warmer cells close to the bottom frame or patchwork patterns) and PV modules positioned close to one of the poles of the module string are strong indications for PID. The most efficient, but more complex and expensive detection method for PID is to take EL images. When taken at 1/10 of the rated current it can detect PID also in an early stage, before a power loss can be noticed. It's because in the early stage, the PID degradation is more pronounced at low light conditions. To quantify the performance loss, I-V measurements have to be performed on the affected string and/or modules. In an advanced stage secondary induced failures like hot-spot's, yellowing and/or corrosion can be sometimes observed.</p>

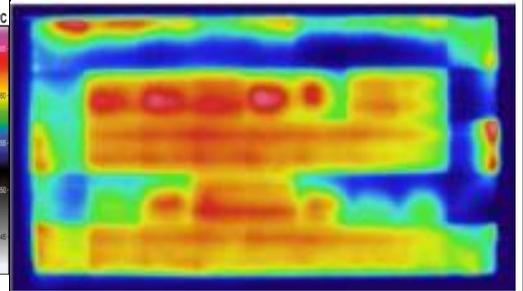
Dark IR thermography at I_{sc} for a module affected by PID. [16]

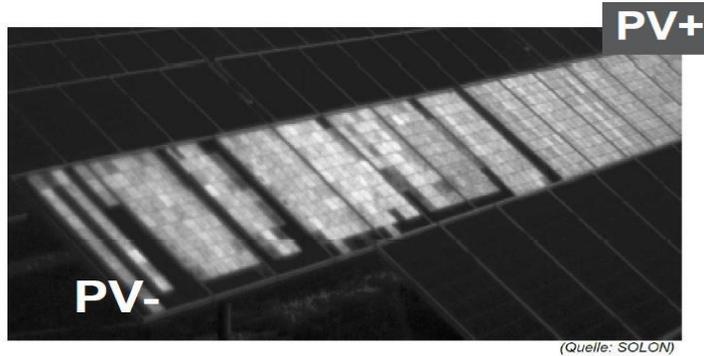
Strings with PID, detected with EL imaging.

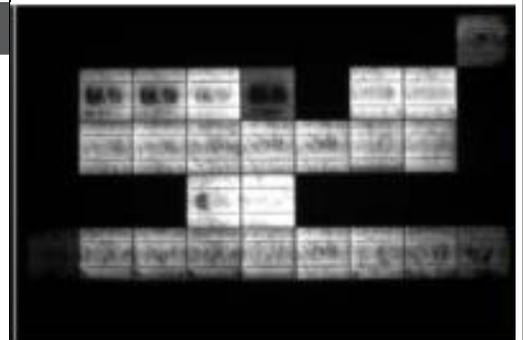
Electroluminescence image made at I_{sc} for a module affected by PID. [16]

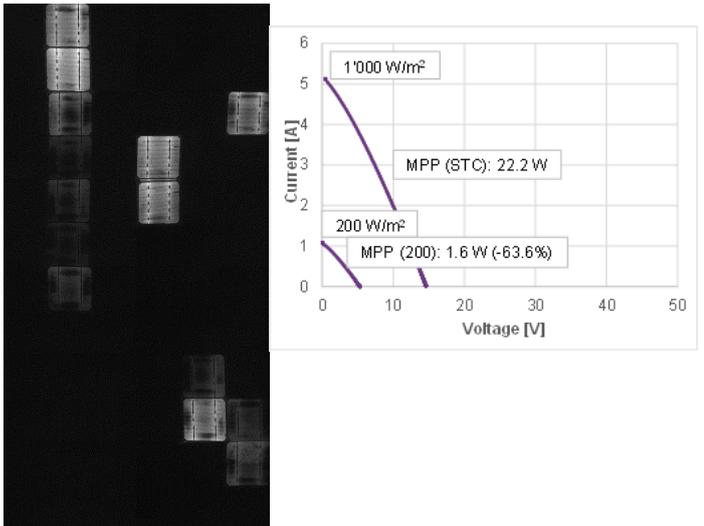
PID affected module with power loss of 89%, left: EL at 1.5 x I_{sc}, right: I-V curve of the same module at 1000 and 200 W/m². [35]

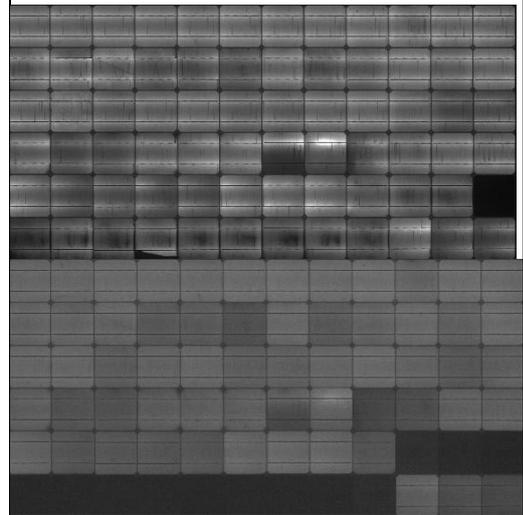
PID affected module with power loss of 14%. top: EL at 1.5 x I_{sc}. bottom: EL of the same module at 0.2 x I_{sc}. [35]

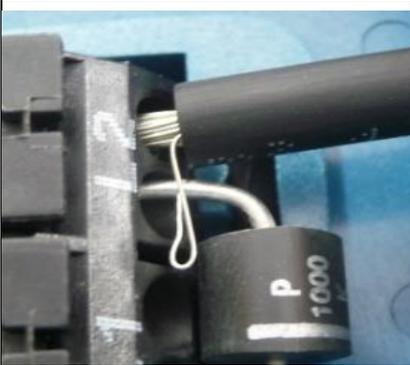
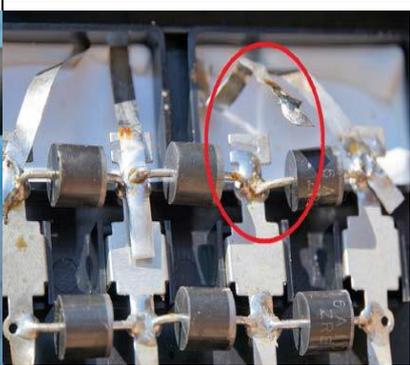
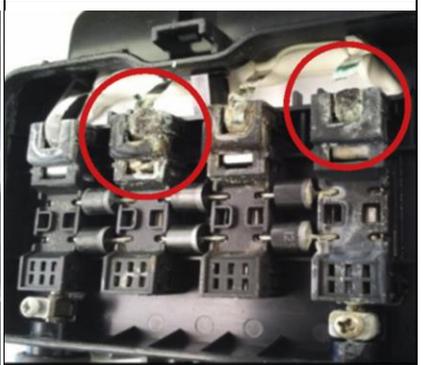
<p>Examples 1-3</p>

<p>Junction box with poor wiring. [16]</p>	<p>Detached tabbing ribbon due to bad soldering. [16]</p>	<p>Corrosion failure due to water soaking of the IP65 rated Jbox. [41]</p>
<p>Severity</p>

Component Defect	Module	PVFS 1-14vs.01	
Appearance	Not connected, broken, burned, corroded or short circuited parts within the junction box. It can involve solder joints, wires, bypass diodes or tabbing ribbons. The interconnection failure itself could be hidden by the potting material in the junction box and be visible only by removing the potting material. The material can appear as degraded (yellowed, browned, burned or bubbled) due to the heat or arcing occurring in the junction box.		
Detection	IRT, (VI, IV, VOC)		
Origin	Bad contacts or moisture ingress may be the cause of interconnection failures in the junction box. Contacts are either soldered, screwed or inserted (mechanical spring clamping). Bad soldering contacts are caused by low soldering temperature (cold solder point) or chemical residuals of the previous production process on the solder joints. Bad mechanical contacts are caused by loose clamping or screws. Mechanical contacts can get loose due to the thermal cycling of day and night and seasonal changes. Moisture ingress in bad or damaged junction boxes (e.g. adhesion loss, brittle, cracked, missing seal at wire entrance or junction box housing) leads to corrosion of the contacts. Delamination near the junction box can cause it to become loose, putting mechanical stress on the contacts within the junction box and breaking them.

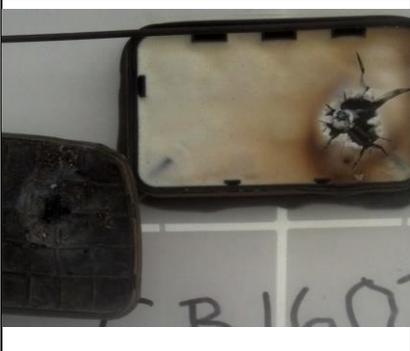
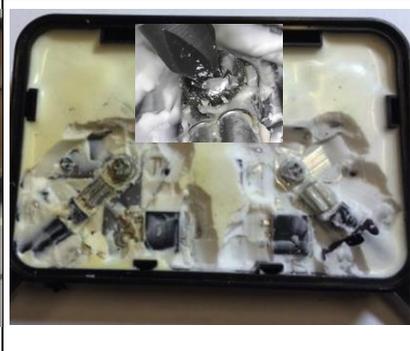
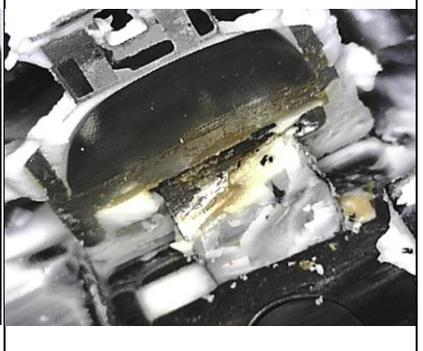
<p>Examples 4-6</p>

<p>Jbox failure due to poor electric connection. [41]</p>	<p>Evidence of loose screw connection inside Jbox with browning of pottant. [41]</p>	<p>Cold soldering of module busing ribbon to the Jbox connection terminal pad with minor browning of pottant. [41]</p>
<p>Severity</p>

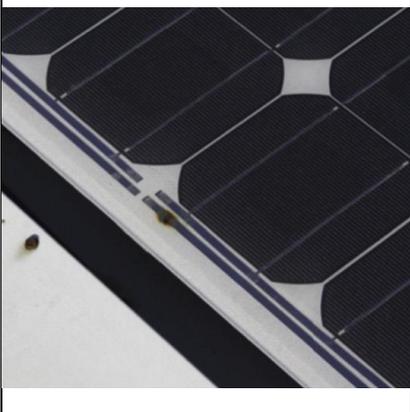
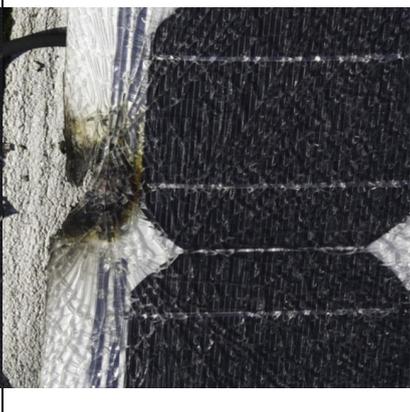
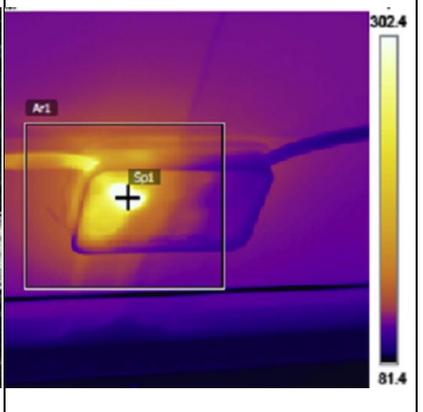
<p>Examples 7-9</p>

<p>Overheating due to the poor Jbox interconnect leading to light discoloration and burn mark on front and back side. [41]</p>	<p>Overheating due to the poor Jbox interconnect leading to burn mark and glass breakage. [41]</p>	<p>IR imaging of a hotspot Jbox due to loose electric connection inside. [41]</p>

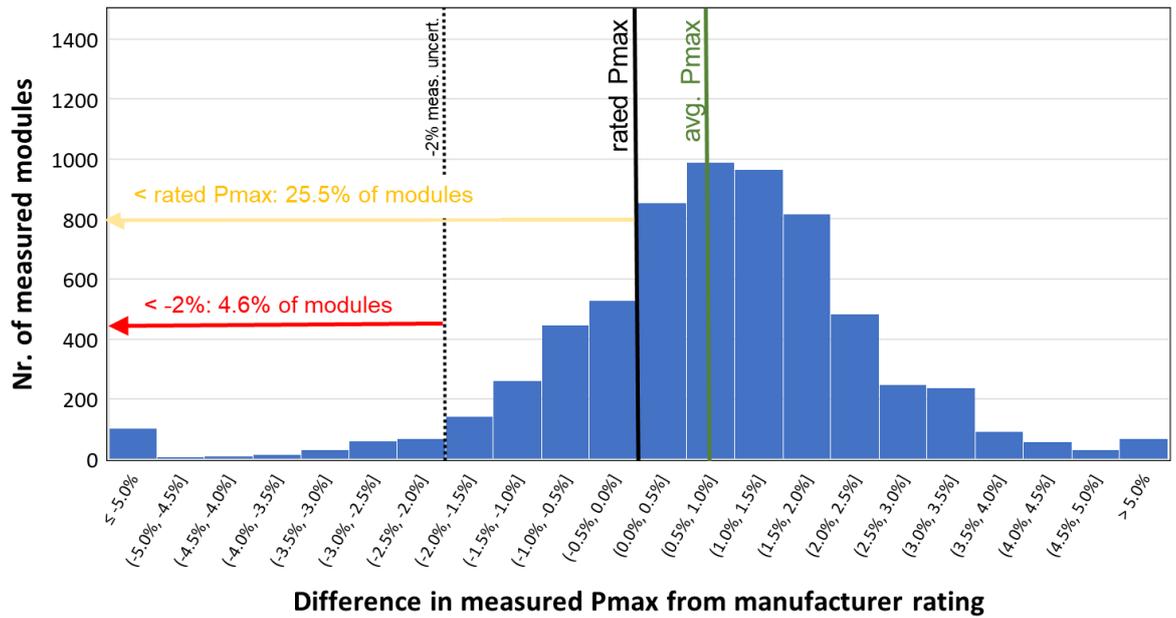
Examples
2

Statistical analysis done by Eternalsun on around 6500 new modules with 96 different PV module types from 29 different manufacturers. [35] Considering the measurement uncertainty of +/-2% a total of 4.6% of the modules are below the gate 1 limit defined by the IEC 61215 standard. [IEC 61215-1:2021]

Note: In case of a measurement uncertainty of +/-5% none of the PV modules would fail, but it would be not conform to the IEC 61215 standard prescribing a maximum measurement uncertainty for c-Si modules of +/-3%.

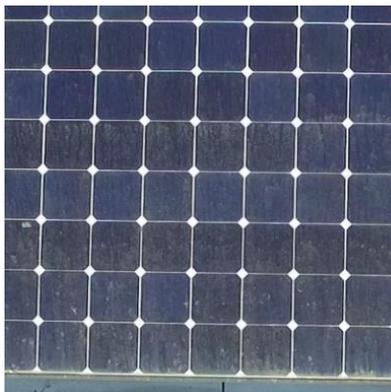
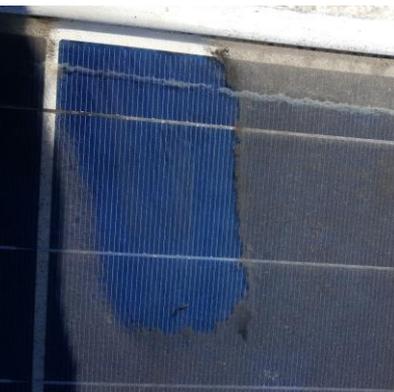
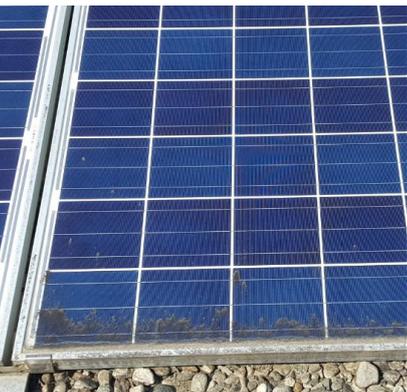
<p>Examples 1-3</p>

<p>Uniform light soiling, which in ideal conditions is self-cleaning when raining.</p>	<p>Uniform heavy soiling caused by rail way station. [SUPSI]</p>	<p>Non-uniform soiling caused by low inclination and close mounting to roof. [SUPSI]</p>
<p>Severity</p>

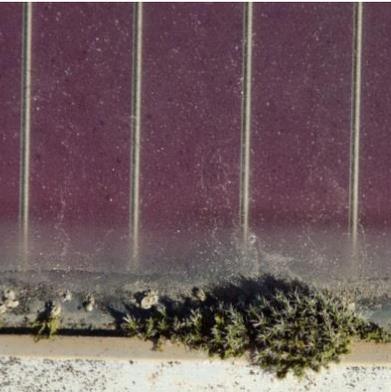
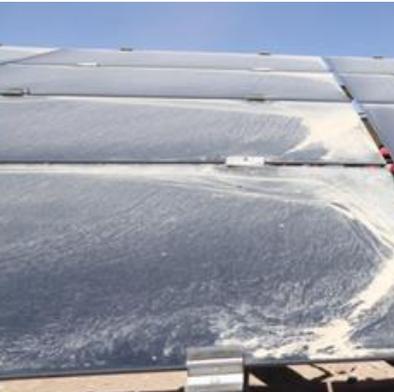
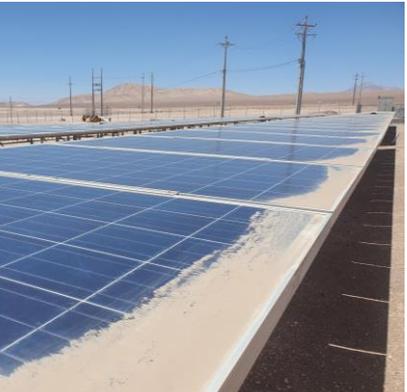
<p>Examples 4-6</p>

<p>Moss growing on the edge of a module combined with edge soiling. [1]</p>	<p>Soiling pattern on a system in the Atacama desert. [ISE]</p>	<p>Soiling pattern demonstrating dominant wind direction on a test site in Atacama desert. [ISE]</p>
<p>Severity</p>

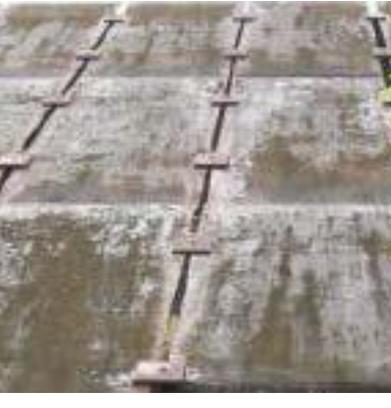
<p>Examples 7</p>

<p>Heavy biofilm soiling. [46]</p>		
<p>Severity</p>

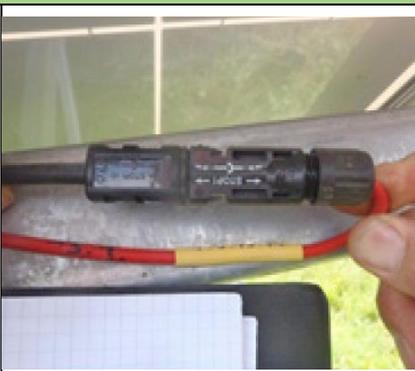
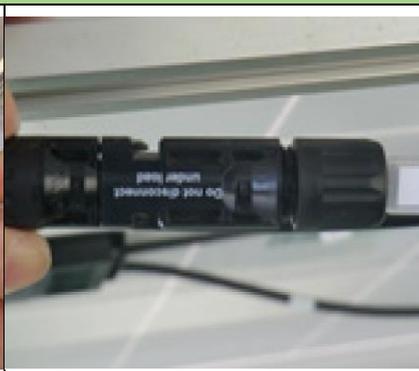
<p>Examples 1-2</p>

<p>Connectors (male of female) are of different brand or type and obviously do not match. [40]</p>	<p>Connectors (male of female) are of different brand or type and obviously do not match. [40]</p>				
<p>Severity</p>

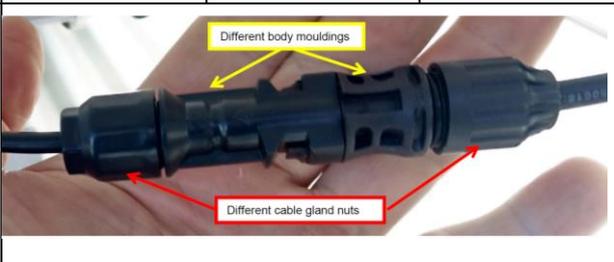
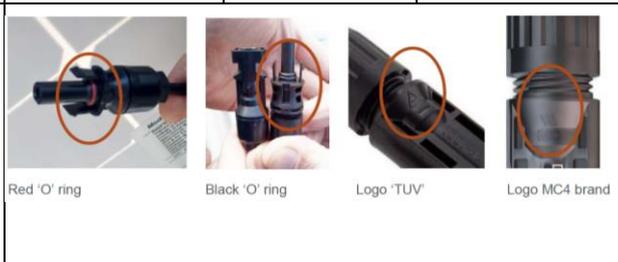
<p>Examples 6-7</p>

<p>Different types of connectors recognizable by different 'O' rings or logos. [ESV guide]</p>			
<p>Severity</p>

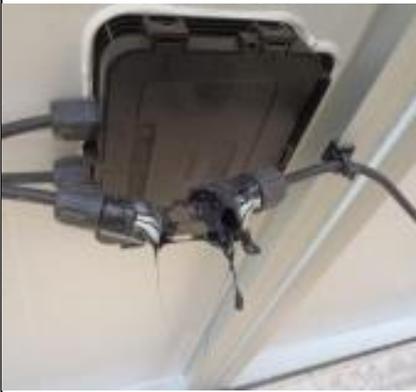
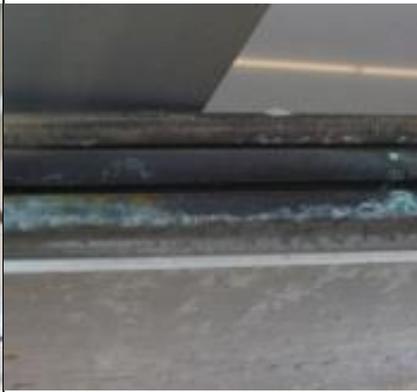
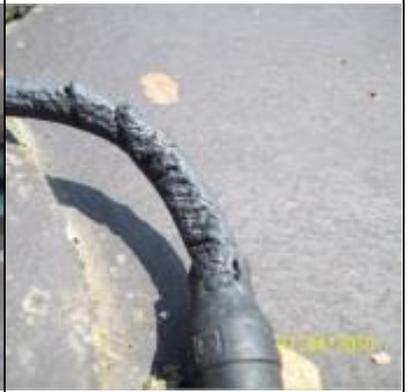
<p>Examples 8-10</p>

<p>Burned connector. [1]</p>	<p>Corroded Cable. [1]</p>	<p>Animal bite on cable. [1]</p>			
<p>Severity</p>

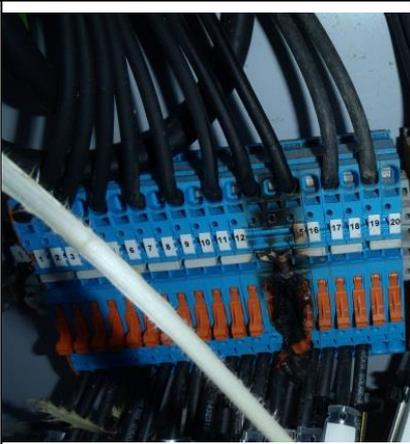
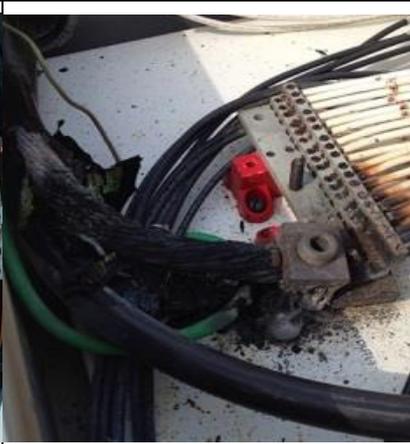
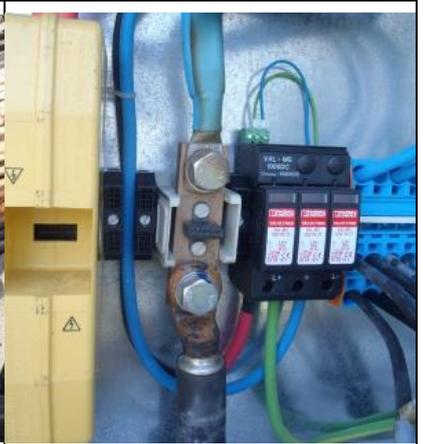
<p>Examples 1-3</p>

Component	Cables and Interconnectors			FS 2-4vs.01
Defect	Thermal damage in combiner box			
Appearance	Defects appearing in the combiner box as discoloured or burned cable interconnections or fuses. Damaged parts can be found by visual inspection or infrared thermography (IRT).			
Detection	VI, IRT, (MON)			
Origin	Thermal damages in the combiner box can be due to the selection of inadequate components (e.g underrated fuses or fuse holders), a not proper connection of DC cables (e.g improper wire torqueing, missing fuses) or a wrong wiring of the modules/strings in the field or on-roof.			
	Production <input type="checkbox"/>	Installation <input type="checkbox"/>	Operation <input type="checkbox"/>	
Impact	This damage is caused by the excess heat generated in fuse holder and defect DC connectors/cables . The partial or complete thermal damage of the combiner box leads to performance losses, electrical shock hazards and risk of fire. Actions must be taken immediately by qualified personnel to prevent further damage.

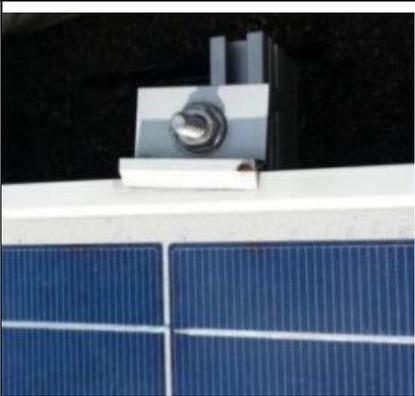
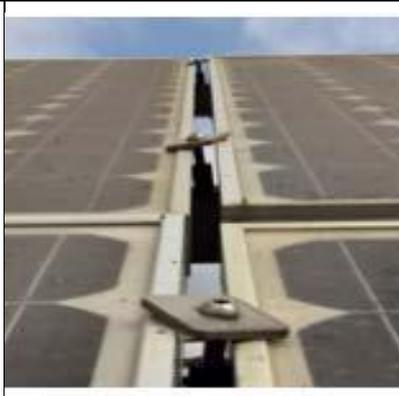
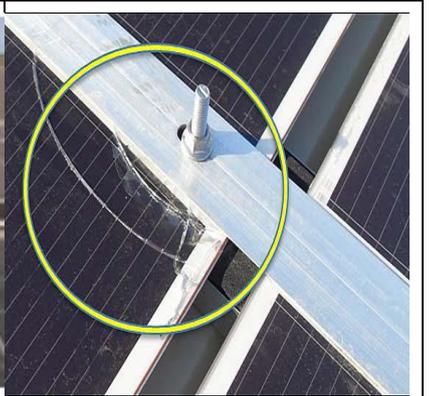
<p>Examples 1-3</p>

<p>Improper installation of clamp. [?]</p>	<p>Wrong combination of clamps and modules. [40]</p>	<p>Glass breakage caused by too tight screws. [35] (see also PVFS 1-8)</p>
<p>Severity</p>

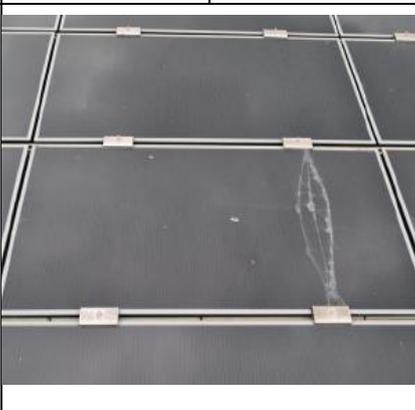
<p>Examples 4</p>

<p>Glass breakage caused by poor clamp design. [40] (see also PVFS 1-8)</p>		
<p>Severity</p>

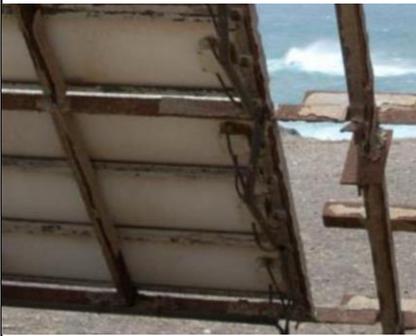
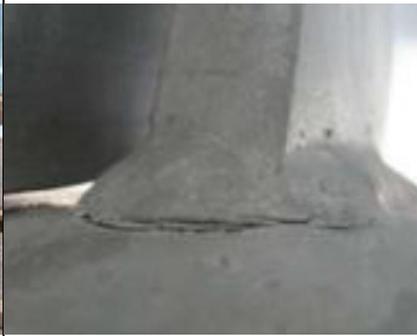
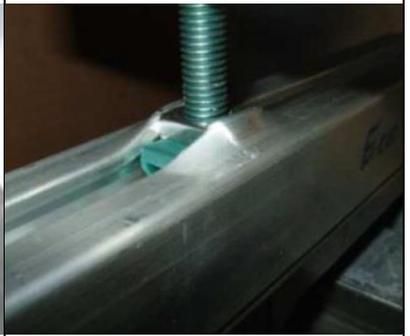
<p>Examples 1-3</p>

<p>Corrosion due to salt water. [46]</p>	<p>Cracks in mounting structure due to mechanical stress. [46]</p>	<p>Screw canal bends due to mechanical stress. [46]</p>			
<p>Severity</p>

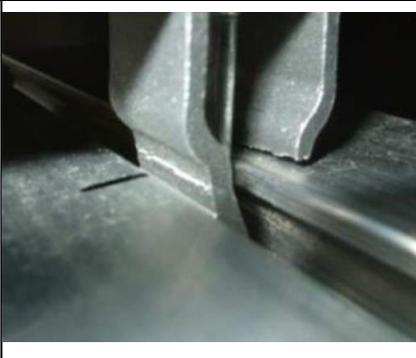
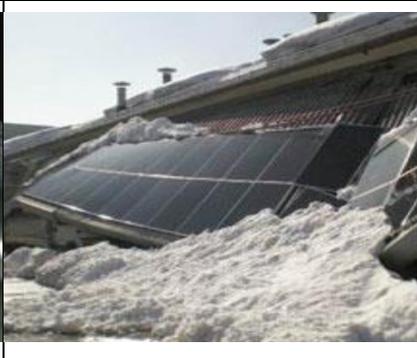
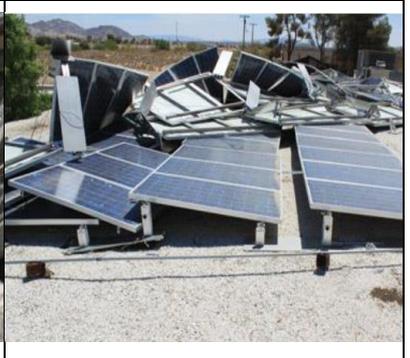
<p>Examples 4-6</p>

<p>Bracket fractured due to mechanical stress. [46]</p>	<p>Undersized mounting structure for local snow load conditions. [46]</p>	<p>Undersized mounting structure for local wind conditions. [15]</p>			
<p>Severity</p>

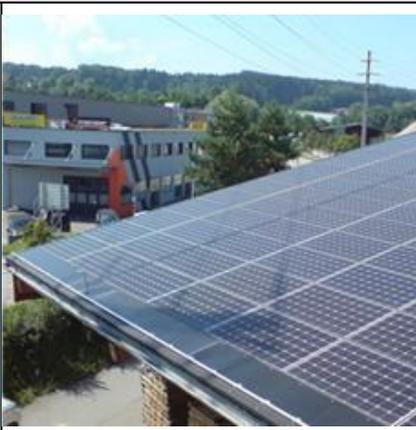
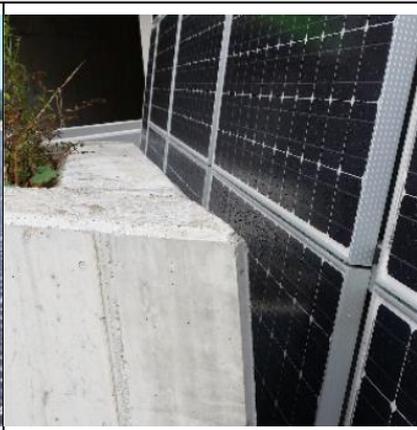
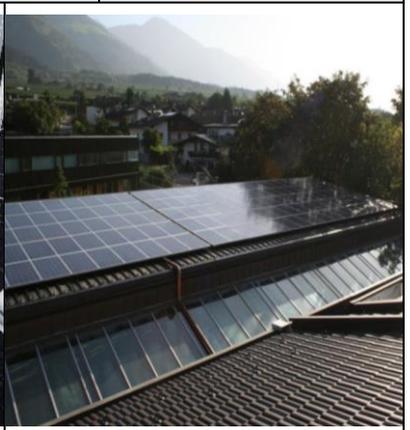
<p>Examples 1-3</p>

<p>Shading by pole-and-wire (poor design: too close to nearby shading objects). [36]</p>	<p>Shading due to bad planning or coverage by afterwards build construction element. [40]</p>	<p>Shading by tree with seasonal changes due to foliage. [40]</p>			
<p>Severity</p>

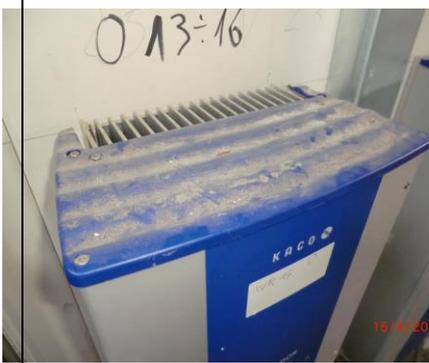
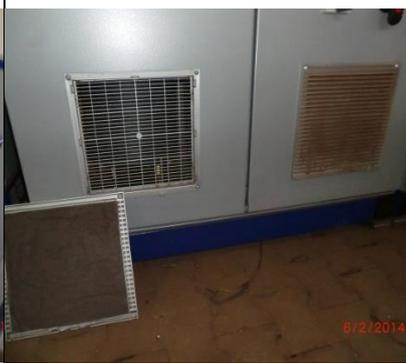
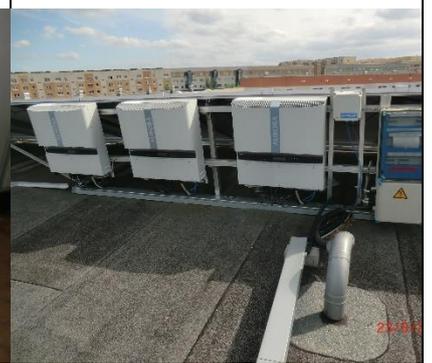
Examples
1-3

Dust blocking heat dissipation [TUV Rheinland]

A soiled air filter causes overheating [TUV Rheinland]

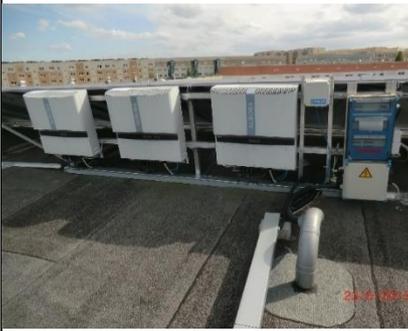
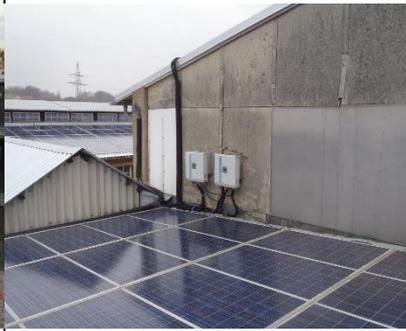
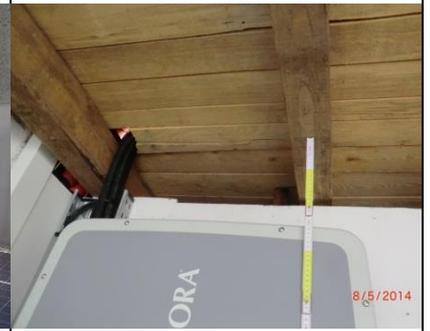
Examples
1-3

Installation in direct sun light. [TUV Rheinland]

Inverters are not or difficult accessible for operation and maintenance. [TUV Rheinland]

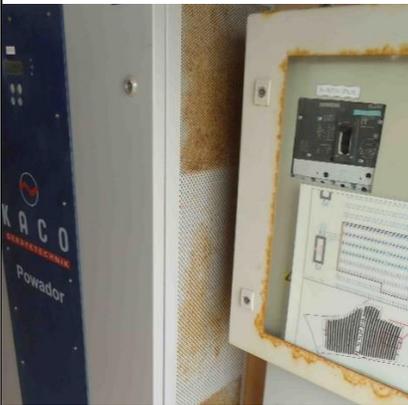
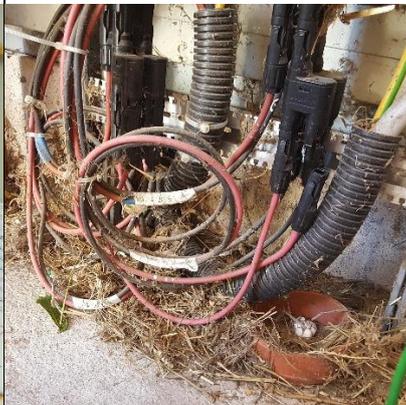
Examples
4-5

Housing not appropriate. [TUV Rheinland]

Presence of inflammable material. [SUPSI]

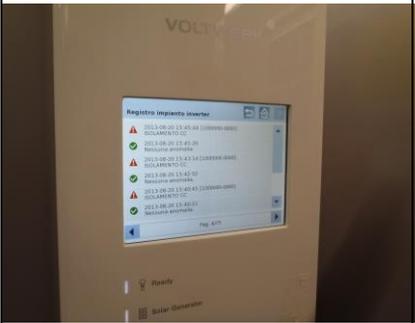
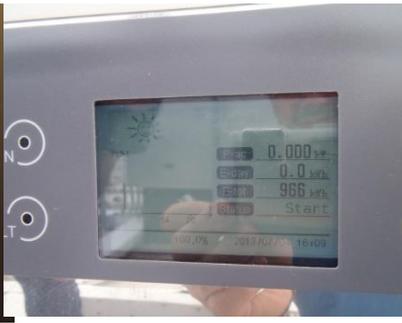
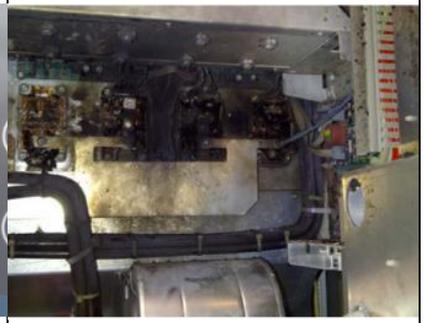
Examples
1-3

Insulation failure. [TUV Rheinland]

Not operating inverter. [TUV Rheinland]

Damaged hardware component. [37]
